## 1.0 INTRODUCTION

## 2.0 2022 EWM MONITORING & MANAGEMENT ACTIVITIES

Map 4  
Eagle Lake  
Vilas County, Wisconsin  
**2022 EWM Peak-Biomass  
Survey Results**

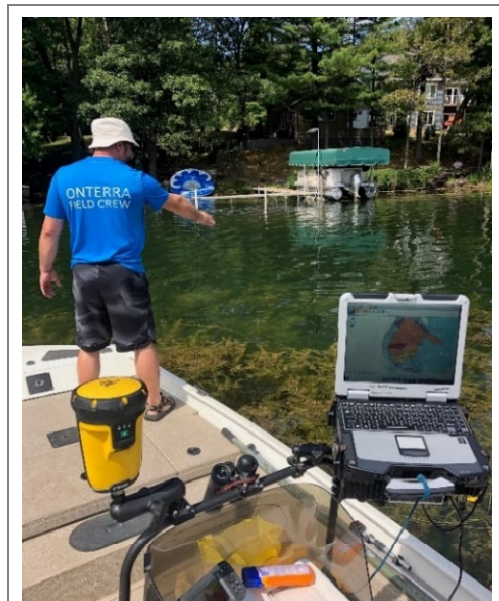
**Photo 1.1-2. EWM mapping survey on a WI lake.** Photo credit Onterra.

A series of EWM mapping surveys were used to coordinate and monitor the hand-harvesting efforts. During the EWM mapping survey, the entire littoral area of the lake is surveyed through visual observations from the boat (Photo 1.1-2). A preliminary hand harvesting strategy is developed over the fall/winter based on the results of the previous year's Late-Summer EWM Mapping Survey. In late-spring/early summer, an Early Season Aquatic Invasive Species Survey (ESAIS) is completed from which the hand-harvesting strategy was finalized. After the professional hand-harvesting activities are completed, Onterra completes the Late-Summer EWM Mapping Survey, the results of which serve as a post-harvesting assessment of the hand-removal efforts. The hand-removal program would be considered successful if the EWM population within the targeted areas was found to have been reduced and inhibited from expanding between the year before and year after Late-Summer EWM Mapping Surveys.

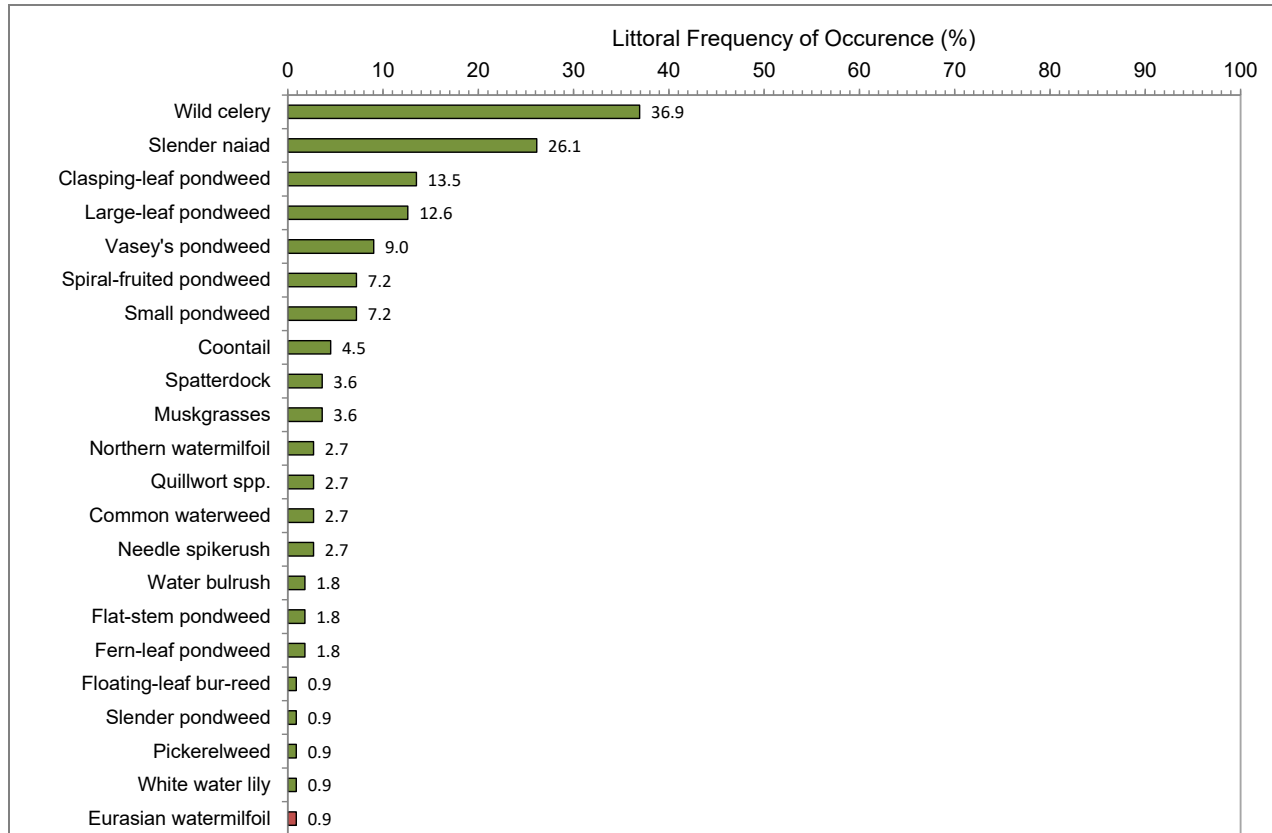
**Figure 4.4-1. Eagle Lake littoral frequency of occurrence of aquatic plant species from 2022 point-intercept survey.**

The whole-lake point-intercept survey was conducted in Eagle Lake on July 19<sup>th</sup>, 2022, and 22 native aquatic plant species were recorded. Wild celery, slender naiad, clasping-leaf pondweed, and large-leaf pondweed were the most frequently encountered species.

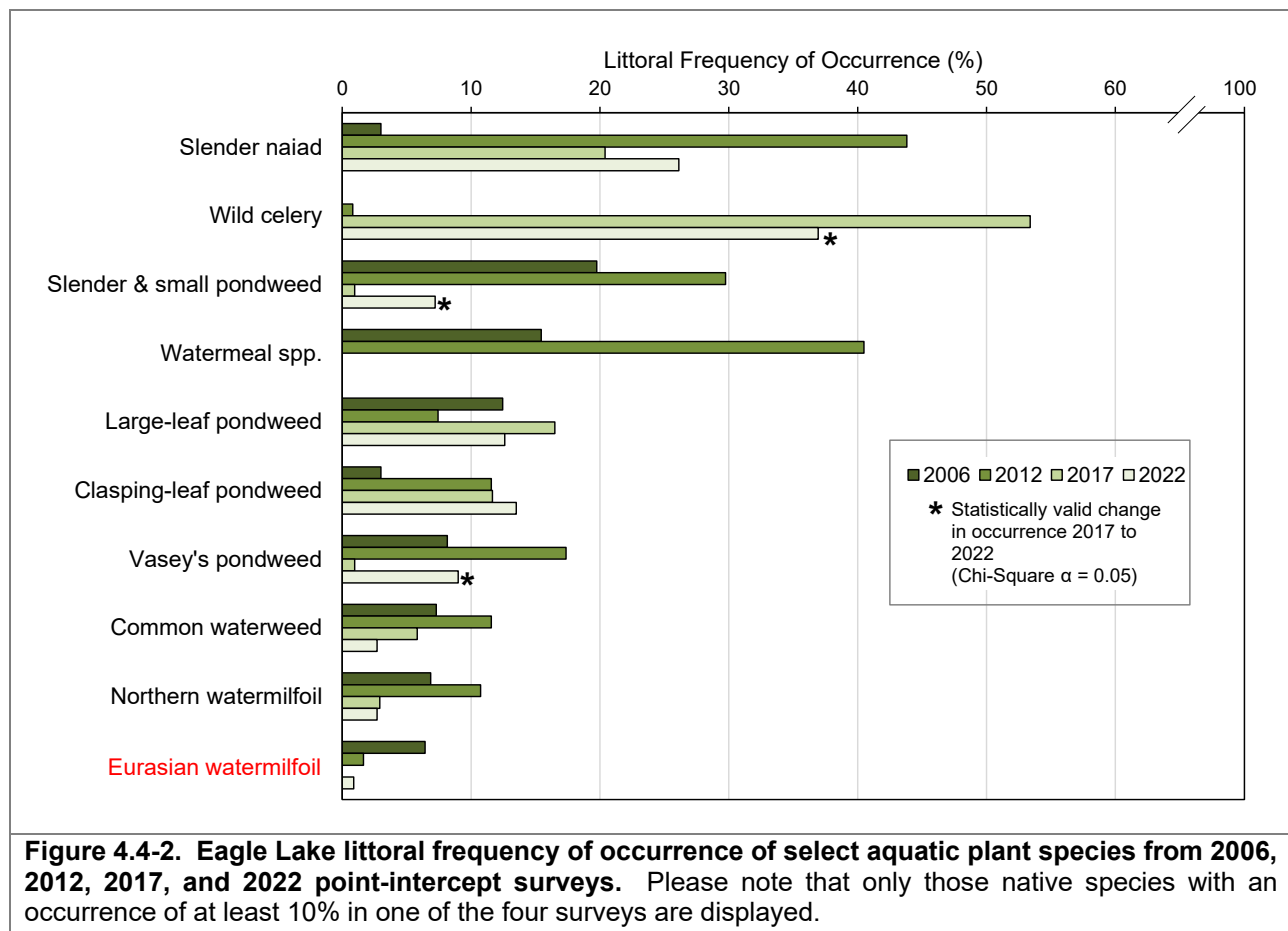
Eurasian watermilfoil was present at one sampling location in the 2022 survey, representing an occurrence of 0.9%. The occurrence of EWM has been relatively low in all past surveys with values of 6.4% in 2006, 1.7% in 2012, and 0% in 2017 (Figure 4.4-2).
