## 1.0 INTRODUCTION

Figure 1.0-1 Lower Eagle River Chain of Lakes, Vilas-Oneida Counties.

## 4.7 Lynx Lake

Map 7  
**Lynx Lake**  
 Vilas County, Wisconsin  
**2022 EWM Peak-Biomass**  
**Survey Results**

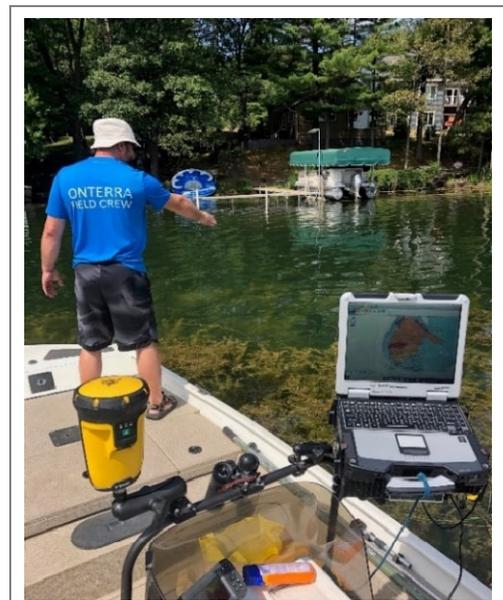
Photo 1.1-2. EWM mapping survey on a WI lake. Photo credit Onterra.

A series of EWM mapping surveys were used to coordinate and monitor the hand-harvesting efforts. During the EWM mapping survey, the entire littoral area of the lake is surveyed through visual observations from the boat (Photo 1.1-2). A preliminary hand harvesting strategy is developed over the fall/winter based on the results of the previous year's Late-Summer EWM Mapping Survey. In late-spring/early summer, an Early Season Aquatic Invasive Species Survey (ESAIS) is completed from which the hand-harvesting strategy was finalized. After the professional hand-harvesting activities are completed, Onterra completes the Late-Summer EWM Mapping Survey, the results of which serve as a post-harvesting assessment of the hand-removal efforts. The hand-removal program would be considered successful if the EWM population within the targeted areas was found to have been reduced and inhibited from expanding between the year before and year after Late-Summer EWM Mapping Surveys.
