## 1.0 INTRODUCTION

Figure 1.0-1 Lower Eagle River Chain of Lakes, Vilas-Oneida Counties.

## 2.0 2022 EWM MONITORING & MANAGEMENT ACTIVITIES

## 4.6 Otter Lake

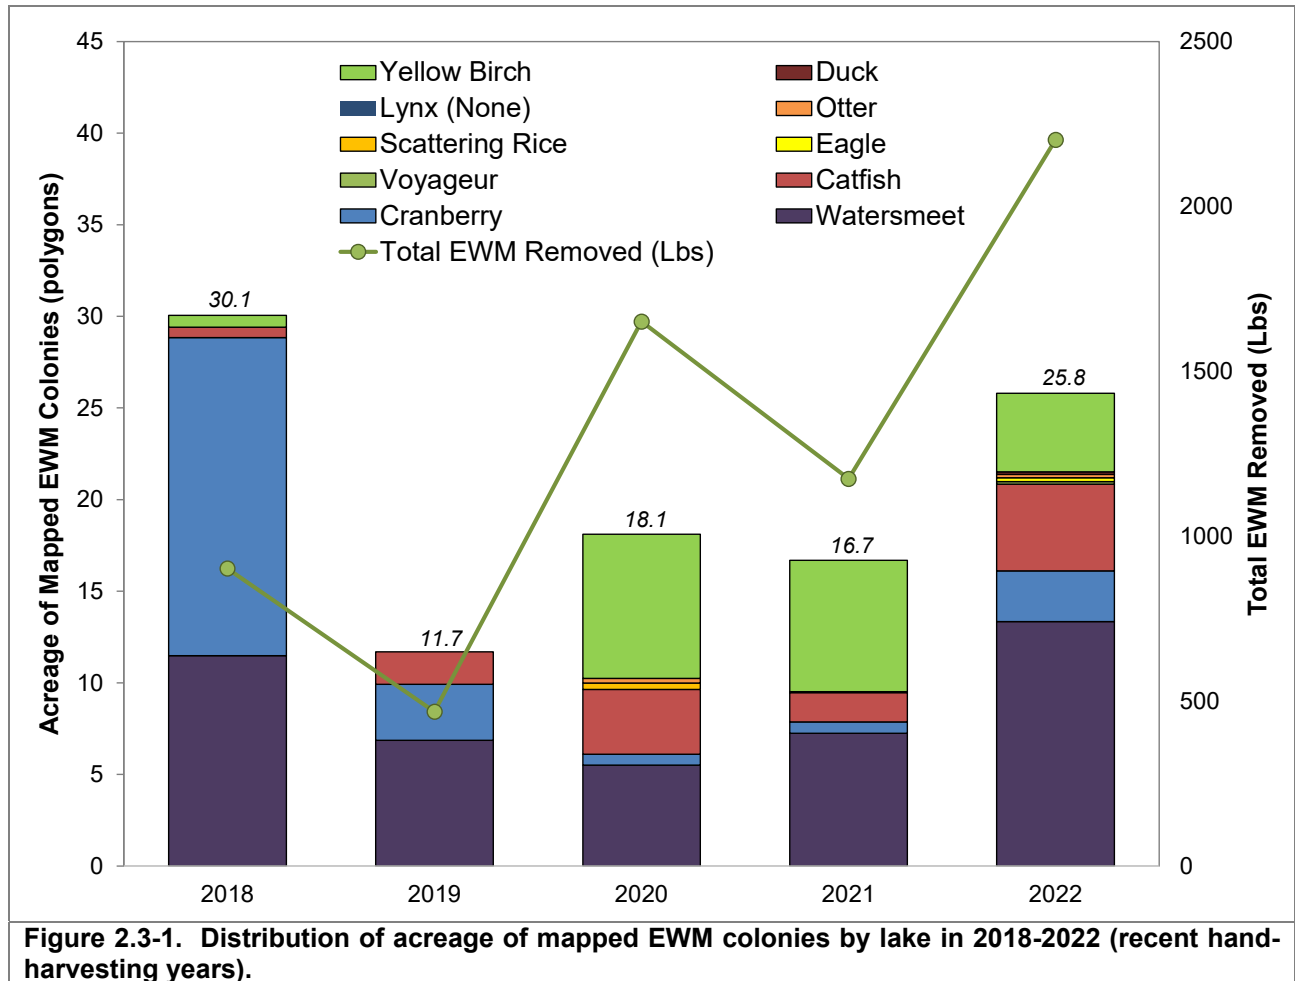
As shown on Figure 2.3-1, 25.8 acres of EWM was located during the 2022 Late-Season EWM Mapping Survey on the Chain. This is an increase compared to the 16.7 acres mapped in 2021 and is much lower than acreages of colonized EWM documented annually from 2007-2009. Historically, the majority of the EWM acreage mapped in the Eagle River Chain of Lakes has been in Cranberry and Watersmeet Lakes. The EWM within these lakes is largely located in channelized areas where water flow is higher. Past herbicide treatments conducted in these areas revealed it is difficult to achieve the needed concentration and exposure time to achieve EWM mortality. In 2020-2022 however, EWM acreage in Cranberry Lake has been very low (1.3-acre average), aside from 2015 when no polygons were mapped at all there.

The highest EWM acreages during the 2022 Late-Season EWM Mapping Survey were from Watersmeet, Catfish, and Yellow Birch Lakes, each with 13.0, 4.7, and 4.3 acres respectively (Figure 2.3-1). All lakes within the chain, with the exception of Lynx and Yellow Birch Lakes, saw increases in EWM during 2022 when compared to 2021.

As colonized EWM populations increased chain-wide from 2021 to 2022, the amount of EWM occurrences marked with point-based methodologies has remained relatively stable during this timeframe in most areas. The majority of point data consists of *single or few plants*.

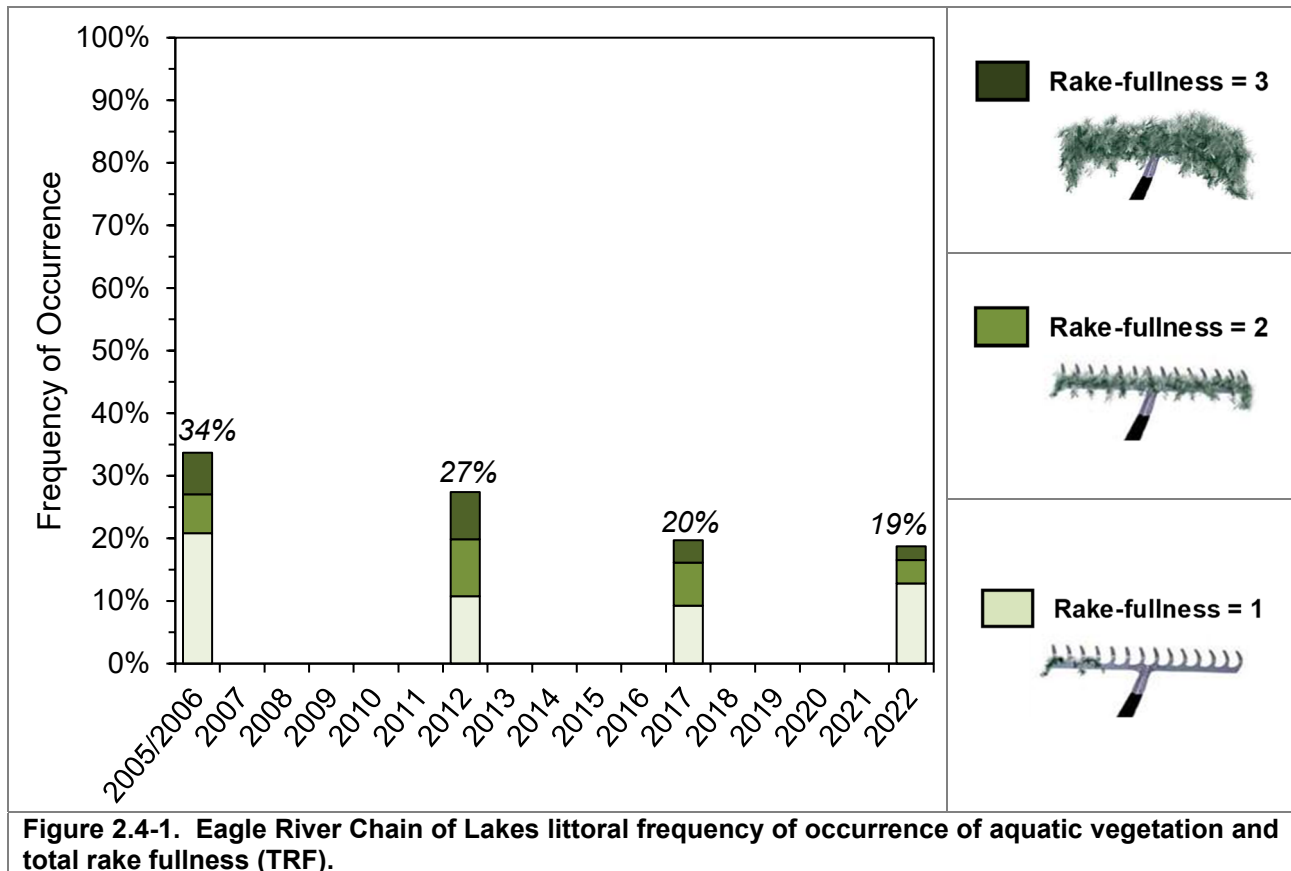
The whole-lake point-intercept surveys were conducted on the Eagle River Chain of Lakes on July 18-21 2022. The results of these surveys can be compared to the results from the 2005/06, 2012, and 2017 point-intercept surveys to determine if any significant changes in the abundance of plants or species composition have occurred over this period. In 2005/06, of the 3,669 point-intercept sampling locations on the Lower Eagle River Chain, 34% contained aquatic vegetation (frequency of occurrence) (Figure 2.4-1). In 2012, the frequency of occurrence of aquatic plants decreased to 27%. In 2017, the frequency of occurrence of vegetation was found to have declined further to 20%. The 2022 surveys showed the frequency of occurrence of vegetation declined again to 19% and less TRF ratings of 2 or 3 were found indicated less biomass. Overall, the frequency of occurrence of native aquatic vegetation in the chain has remained about the same since the 2017 survey.

Since the herbicide (2,4-D amine and 2,4-D ester) used to control EWM on the chain has been shown to have potential adverse impacts to select native aquatic plant species, a link to the decline in the overall occurrence of aquatic vegetation from 2005 to 2017 in the chain was evaluated. The amount of acreage applied with herbicide in the chain was highest from 2008-2010, with an average of 257 acres applied with herbicide per year. The amount of acreage treated from 2011-2015 was lower with an annual average of 69 acres, and no herbicide applications took place between 2016 and 2022. Despite less acreage treated in the chain between 2012-2015 and the absence of herbicide use between 2016-2022, native aquatic plant occurrence has continued to decline.

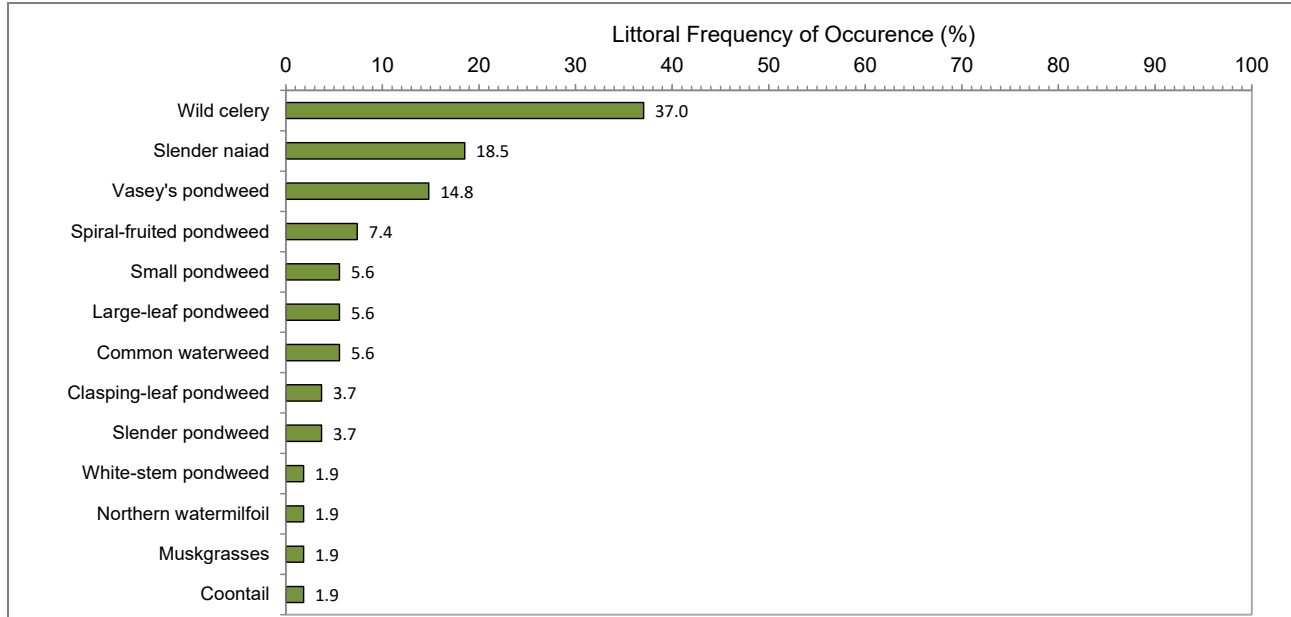
The whole-lake point-intercept survey was conducted in Otter Lake on July 20<sup>th</sup>, 2022 and 13 native aquatic plant species were recorded. Wild celery (37.0%), slender naiad (18.5%), and Vasey's pondweed (14.8%) were the most frequently encountered species in the 2022 survey (Figure 4.6-1).

**Figure 4.6-1. Otter Lake littoral frequency of occurrence of aquatic plant species from 2022 point-intercept survey.**
