## 1.0 INTRODUCTION

## 4.9 Yellow Birch Lake

**2022 EWM Peak-Biomass  
Survey Results & 2023  
Preliminary Hand-Harvest Plan**

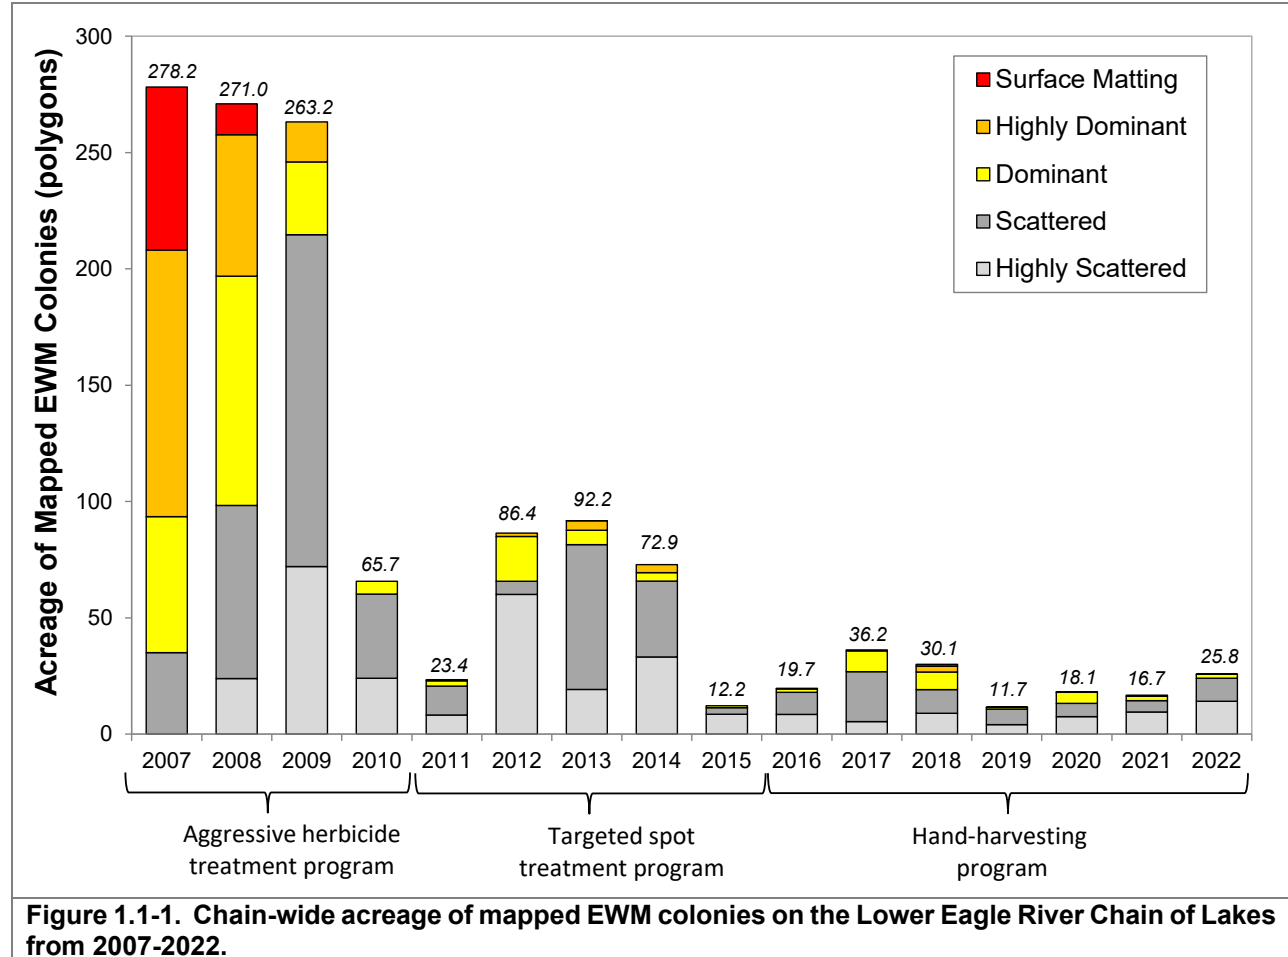
Starting in 2007, late-season EWM mapping surveys commenced on the Eagle River Chain of Lakes using a consistent density rating system (Figure 1.1-1). Please note that this figure only represents the acreage of mapped EWM polygons, not EWM mapped with point-based methodologies (*single or few plants, clumps of plants, or small plant colonies*). Said another way, EWM marked with point-based mapping methods do not contribute to colonized acreage as shown in Figure 1.1-1.

Ongoing studies stemming from this project indicate that in small spot treatments, the herbicide dissipates too rapidly to cause EWM mortality if traditional weak-acid auxin systemic herbicides like 2,4-D are used. Even in some cases where larger treatment areas can be constructed, their narrow shape or exposed location within a lake may result in insufficient herbicide concentrations and exposure times for long-term control. With this knowledge, more effective herbicide spot treatment strategies were implemented in the latter years of this phase of management. In 2015, the EWM population of the Eagle River Chain of Lakes was at its lowest levels in over a decade, with just over 12 acres of colonized EWM being documented chain-wide (Figure 1.1-1).

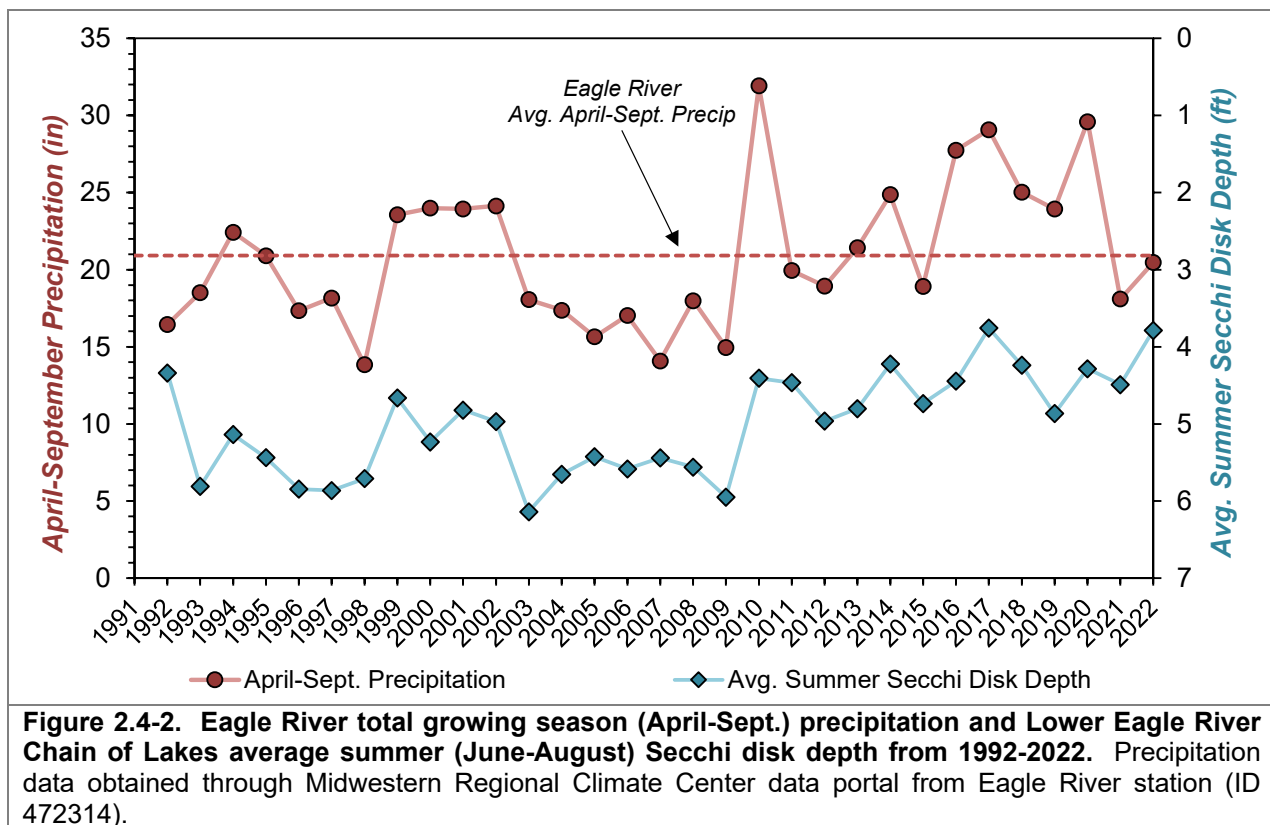
Within the *Comprehensive Management Planning Project*, the role of reduced water clarity caused by above-normal growing season precipitation was investigated in terms of the reduction in native aquatic vegetation over this period. Average chain-wide water clarity has declined by approximately 2.0 feet in recent years, coinciding with increases in precipitation (Figure 2.4-2).

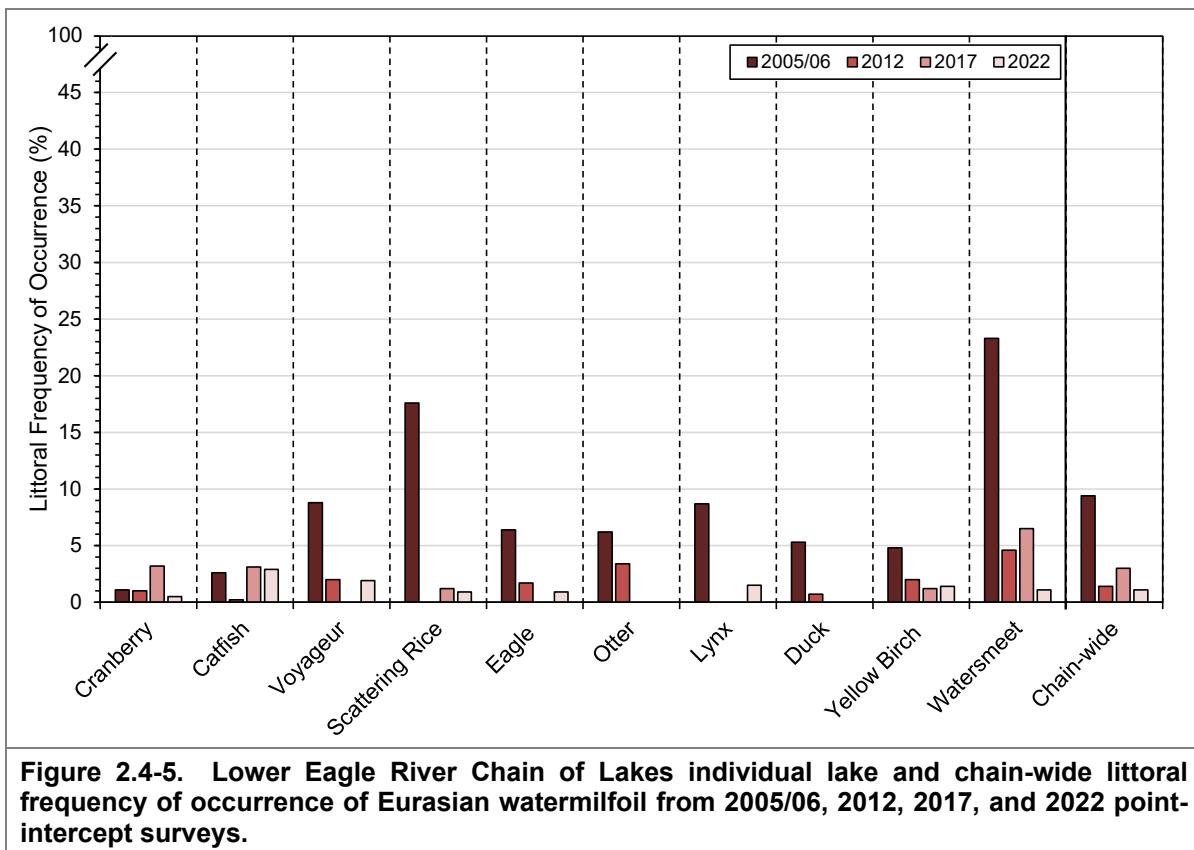
Figure 2.4-5 displays the individual littoral frequency of occurrence of EWM within each of the Eagle River Chain of Lakes from 2005/06, 2012, 2017, and 2022. Between 2005/06 to 2017, the littoral frequency of occurrence of EWM varied within each lake from 0% to 23.3%. In 2022, the littoral frequency of occurrence of EWM in each lake ranged from 0% in Otter Lake to 2.9% in Catfish. As is discussed within the individual lake summary and conclusion sections, ecologists still observed EWM in Otter and Duck Lakes during 2022; however, EWM was not physically encountered on the survey rake during the point-intercept survey which results in an occurrence of 0%.

With the exception of Watersmeet, the lakes within the Lower Eagle River Chain of Lakes have maintained EWM littoral frequencies of occurrence of 3% or less between 2012 and 2022. The 2022 surveys indicate that overall, the EWM population within the Lower Eagle River Chain of Lakes remains low and highlights the continued success of the control and monitoring program. However, areas still remain within the chain that have larger, localized populations of EWM. These areas in 2022 primarily include localized areas in Catfish Lake and the Wisconsin River branch of Watersmeet.

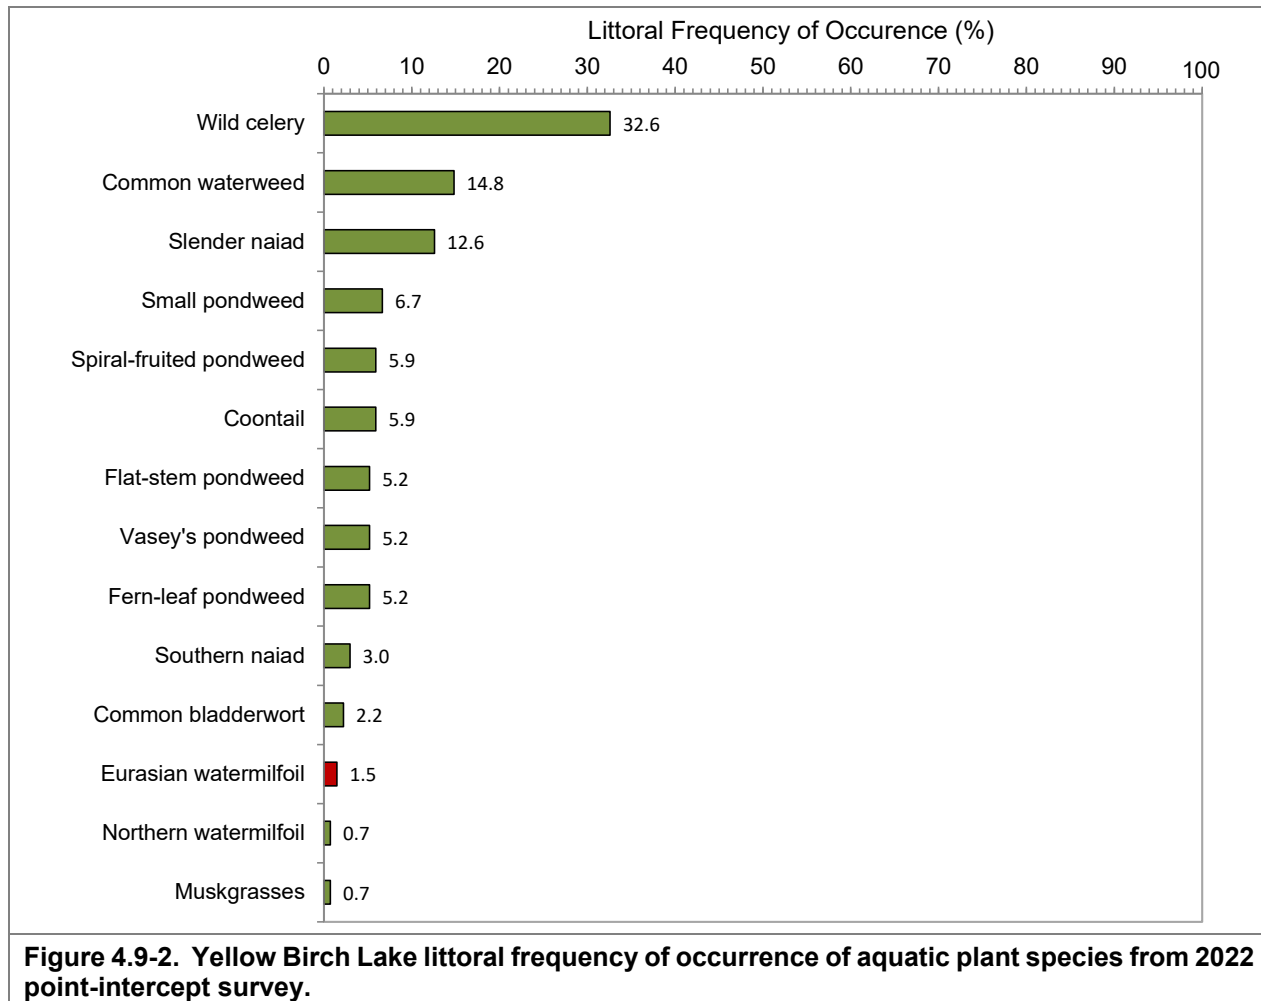
The whole-lake point-intercept survey was conducted in Yellow Birch Lake on July 18-19, 2022 and 21 aquatic plant species were recorded. Wild celery (32.6%), common waterweed (14.8%), and slender naiad (12.6%) were the most frequently encountered species (Figure 4.9-2).

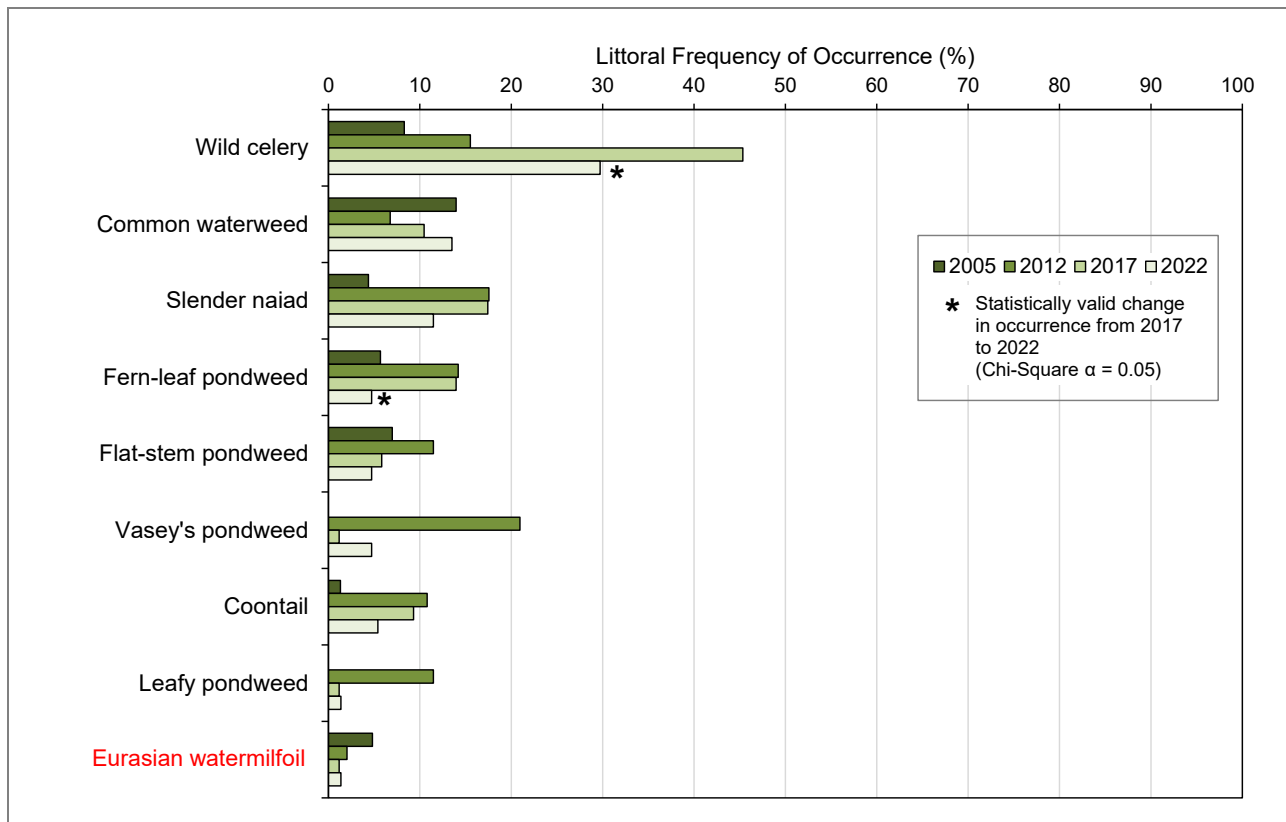
A chi-square analysis ( $\alpha = 0.05$ ) was used to compare individual aquatic plant species littoral occurrences in Yellow Birch Lake between the point-intercept surveys in 2005, 2012, 2017, and 2022 (Figure 4.9-3). Aquatic plant species that had a littoral frequency of occurrence of at least 5% in one of the four surveys are included within the analysis. Most aquatic plants did not show statistically valid changes in occurrence between the 2017 and 2022 surveys. Wild celery and fern-leaf pondweed were the only species that showed statistically valid declines in occurrence between 2017-2022. A table displaying the littoral frequency of occurrence of each aquatic plant species from all four point-intercept surveys is included in Appendix B.

**Figure 4.9-3. Yellow Birch Lake littoral frequency of occurrence of select aquatic plant species from 2005, 2012, 2017, and 2022 point-intercept surveys.** Please note that only those native species with an occurrence of at least 10% in one of the four surveys are displayed.

The occurrence of EWM was 4.8% in 2006, 2.0% in 2012, and 1.2% in 2017. Eurasian watermilfoil was present at two sampling locations in the 2022 survey, resulting in a littoral frequency of occurrence of 1.4%.

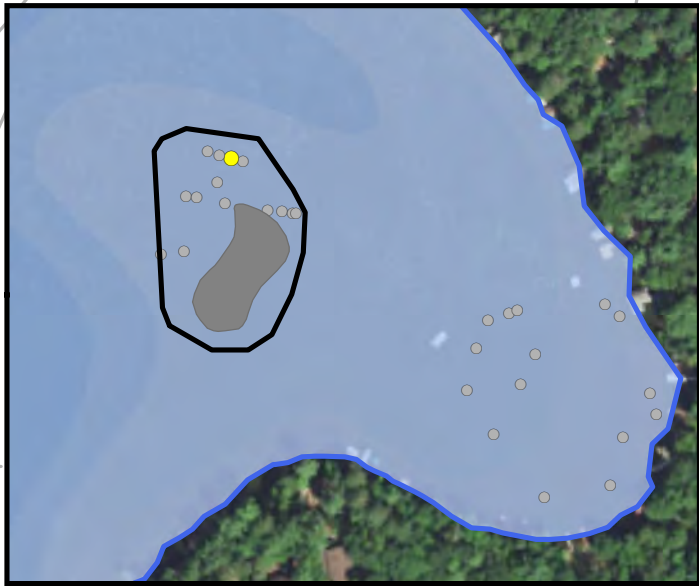
Map 9

Preliminary 2023 DASH Harvesting Areas		
Site	Acres	Ave Depth
<b>Primary Sites</b>		
YBL B-23	1.1	7.0

extents of DASH site YBL B-22 which is being included in a 2023 DASH strategy with the naming convention of YBL B-23 (Map 9). The final DASH harvesting strategy is subject to change pending the results of the 2023 Early-Season AIS survey. Professional EWM monitoring will continue during 2023 including early and late-season AIS surveys.
