**Onterra LLC**  
 Lake Management Planning  
 815 Prosper Road  
 De Pere, WI 54115  
 920.338.8860  
 www.onterra-eco.com

**Yellow Birch Lake**  
 Vilas County, Wisconsin  
**2018 EWM**  
**Hand-Harvesting**  
**Locations**

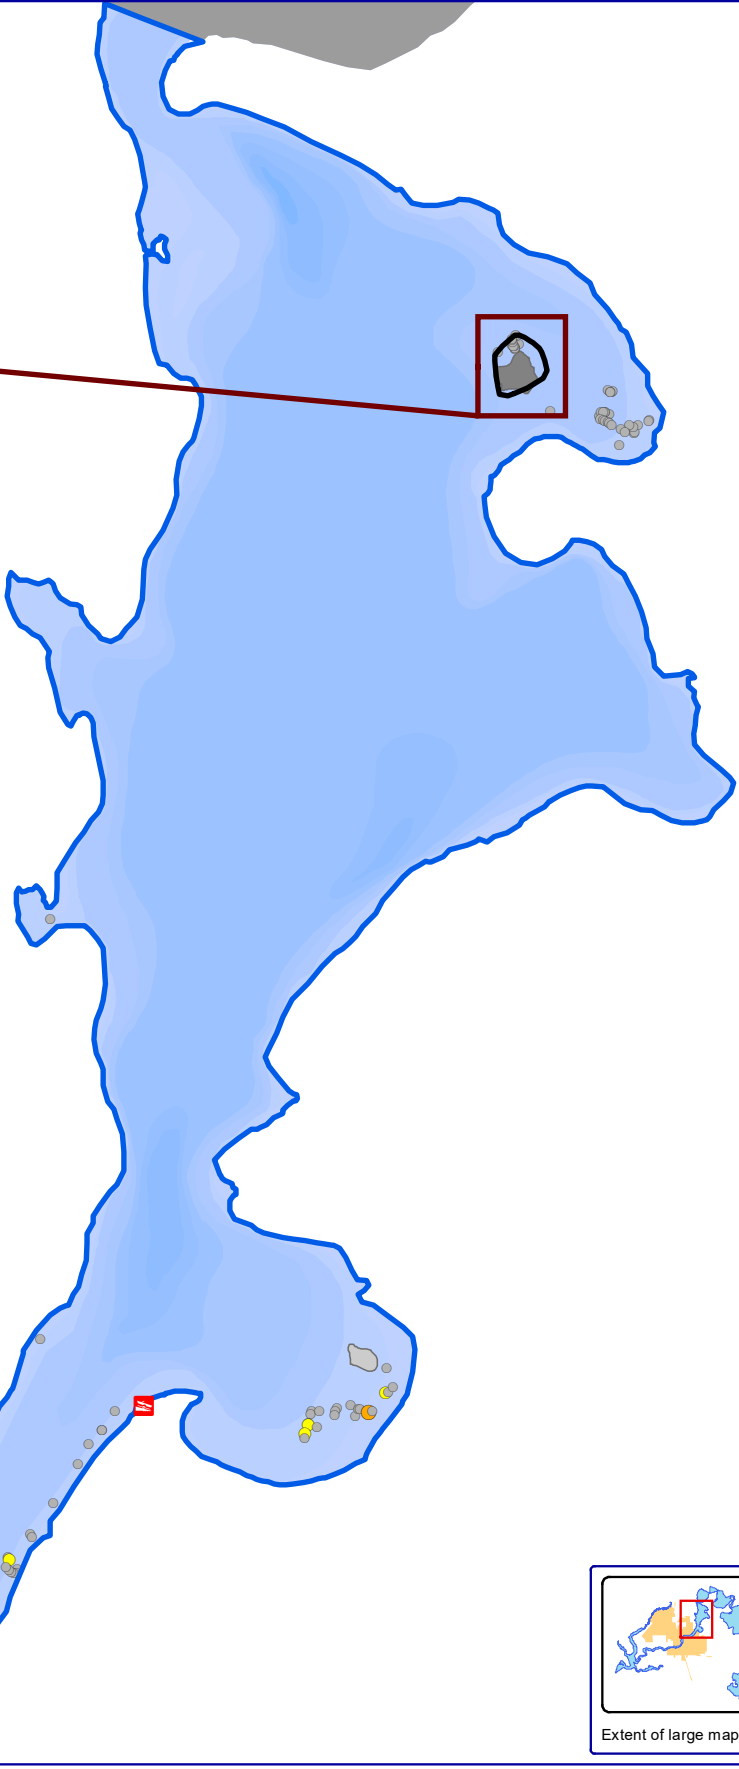
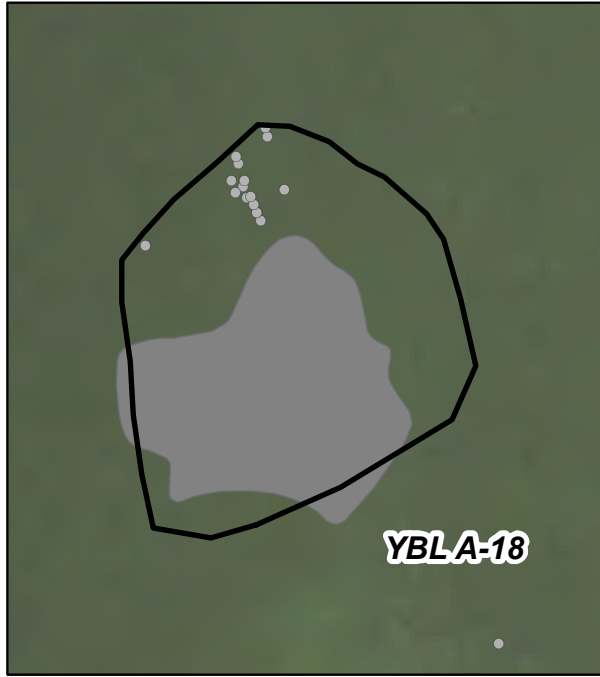
2018 DASH Harvesting Areas				
Site	Acres	Ave Depth (feet)	Sediment	Obstructions / Notes
SCAT A-18	0.82	6.5	Organic / soft	Moderate native plant abundance
SCAT B-18	1.08	4.0	Organic / soft	Moderate native plant abundance
SCAT C-18	0.69	4.0	Organic / soft	Moderate native plant abundance
WAT A-18	3.35	3.0	Organic / soft	Moderate native plant abundance
YBL A-18	0.92	7.0	Organic / soft	Moderate native plant abundance
<b>Total</b>	<b>6.86</b>

- Legend**  
**2018 ESAIS Survey (Early-July 2018)**
- Highly Scattered
  - Scattered
  - Dominant
  - Highly Dominant (None found)
  - Surface Matting (None found)
  - Single or Few Plants
  - Clumps of Plants
  - Small Plant Colony
  - 2018 Hand-Harvesting Work Area
