## 1.0 INTRODUCTION

**Yellow Birch - Map 1**  
Vilas County, Wisconsin  
**2018 EWM PB  
Survey Results**

## 2018 DASH SUMMARY

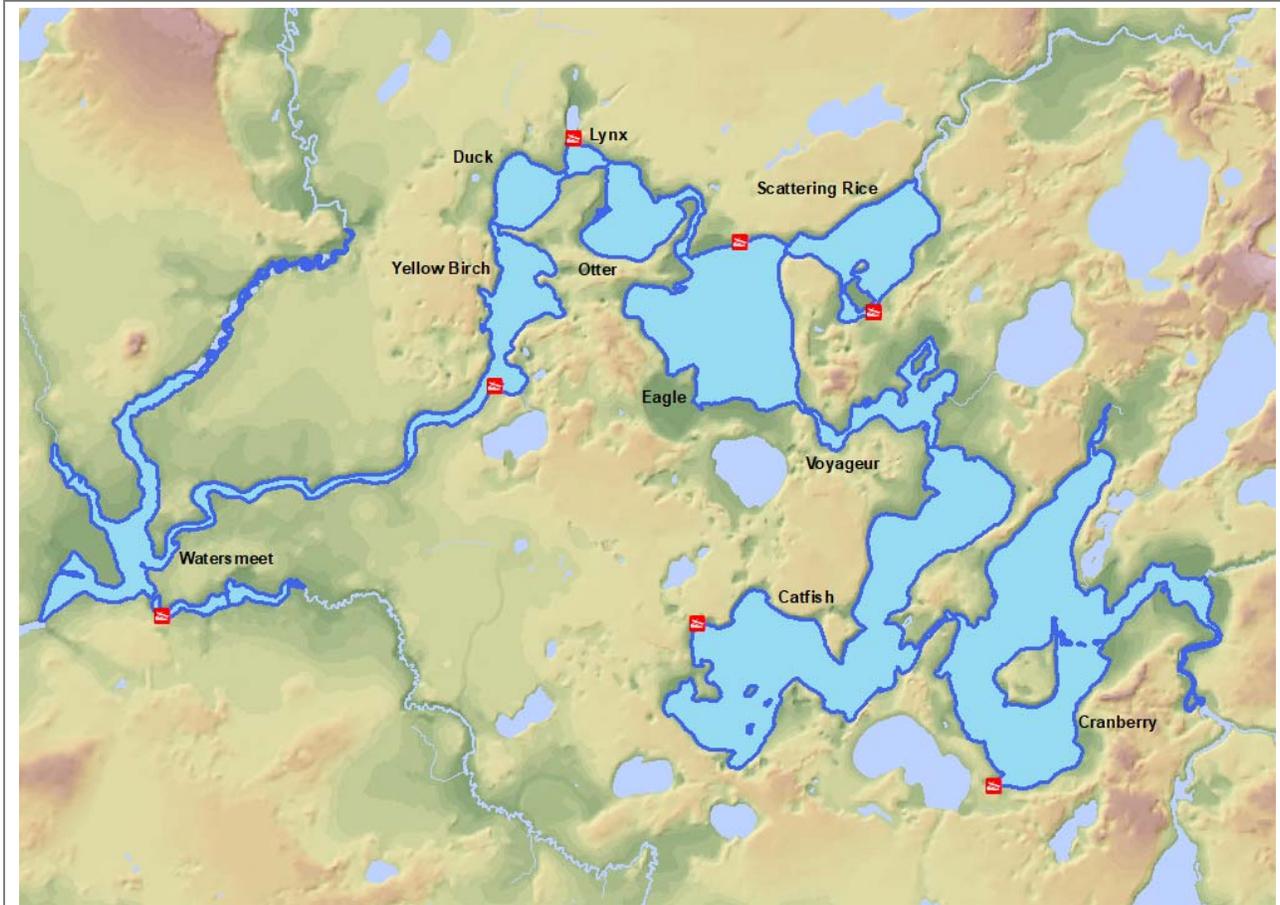
Figure 1. Lower Eagle River Chain of Lakes, Vilas-Oneida Counties.

The Unified Lower Eagle River Chain of Lakes Commission (ULERCLC) has been the successful recipient of Wisconsin Department of Natural Resources (WDNR) Aquatic Invasive Species (AIS) Control Grants since 2007 as they conduct a project aimed at reducing the Eagle River Chain of Lake's (Figure 1). Eurasian watermilfoil (*Myriophyllum spicatum*; EWM) population. This report specifically discusses the monitoring and control activities conducted during 2018. The chain-wide results will be presented first, followed by results from each lake individually. Additional information regarding the management and monitoring actions completed from 2008-2017 can be found in their respective annual reports.

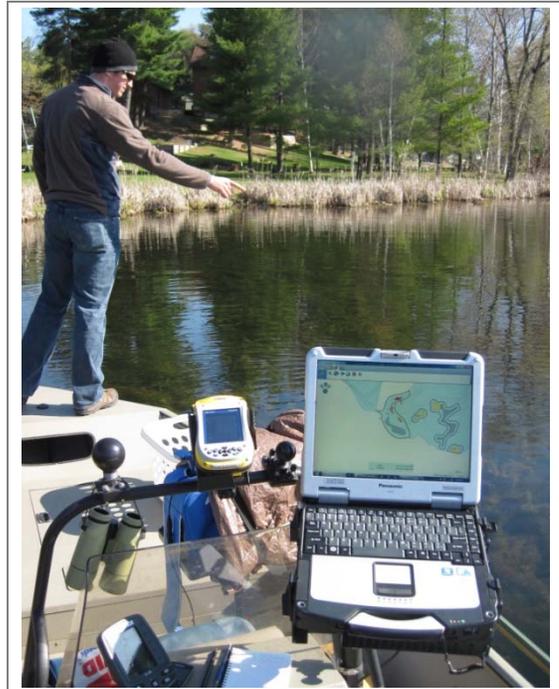
**Photo 1. EWM mapping survey on Cloverleaf Lakes, Shawano County.** Photo credit Onterra.

Onterra ecologists have conducted annual Late-Season EWM Mapping Surveys on the Eagle River Chain of Lakes since 2005. An objective of this survey is to understand the peak growth (peak-biomass) of the EWM population in the system at a fine enough scale to direct and access management actions. An approach that utilizes a combination of volunteer- and professional-based surveys ensures the entire littoral area of the chain is accessed through visual observations from the boat (Photo 1). Onterra field crews ultimately map all discovered EWM populations using sub-meter GPS technology by using either 1) point-based or 2) area-based methodologies (i.e. colonized EWM). Large colonies >40 feet in diameter are mapped using polygons (areas) and were qualitatively attributed a density rating based upon a five-tiered scale from *highly scattered* to *surface matting*. Point-based techniques were applied to AIS locations that were considered as *small plant colonies* (<40 feet in diameter), *clumps of plants*, or *single or few plants*.

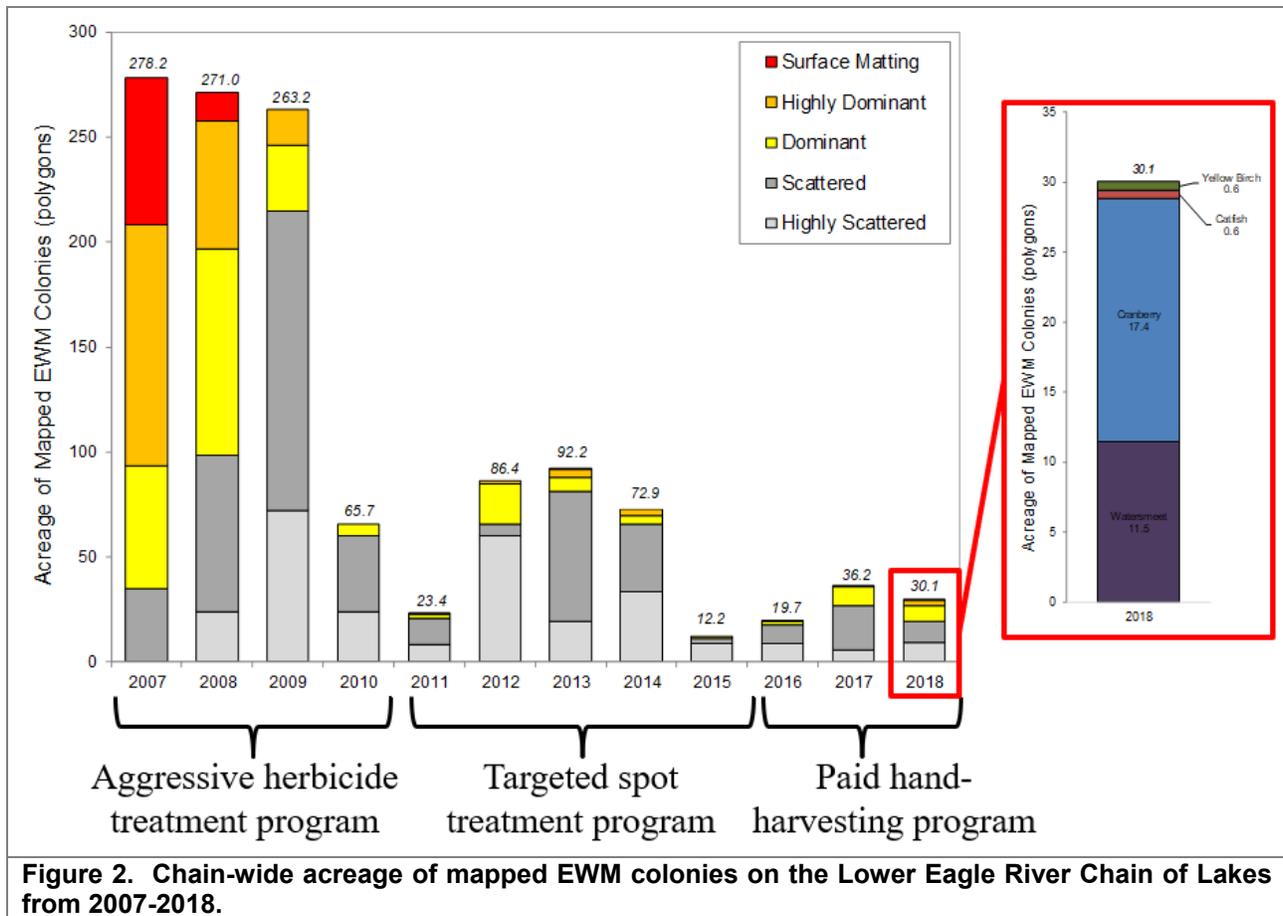
Figure 2 shows the acreage of colonized EWM as well as the distribution of each density rating. Please note that this figure only represents only the acreage of mapped EWM polygons, not EWM mapped within point-based methodologies (*single or few plants*, *clumps of plants*, or *small plant colonies*). Over this same timeframe, the ULERCLC has coordinated active management of EWM.

During this project, the ULERCLC found that some of the herbicide treatments during this time period were not as effective as previous control strategies. Ongoing studies stemming from this project indicate that in small spot treatments, the herbicide dissipates too rapidly to cause EWM mortality if traditional weak-auxin systemic herbicides like 2,4-D are used. Even in some cases where larger treatment areas can be constructed, their narrow shape or exposed location within a lake may result in insufficient herbicide concentrations and exposure times for long-term control. With this knowledge, more efficacious herbicide spot treatment strategies were implemented in the latter years of this phase of management. In 2015, the EWM population of the Eagle River Chain of Lakes was arguably at its lowest levels in over a decade, with just over 12 acres of colonized EWM being documented chain-wide (Figure 2).

Overall, 2018 saw a slight decrease in EWM polygon acreage on a chain-wide basis (Figure 2). While EWM population reductions were observed within a number of the targeted hand-harvesting sites, other areas of the chain that were not actively management also observed EWM population reductions. It has been acknowledged that the conditions of the Eagle River Chain of Lakes, particularly low water clarity, may be more of a driver of the AIS population trajectory in some years than management efforts themselves.

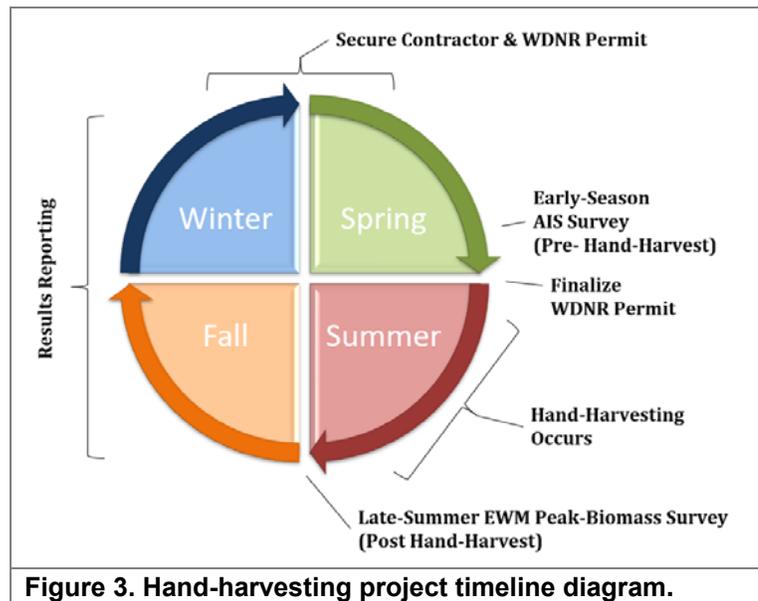
Figure 3. Hand-harvesting project timeline diagram.

Following the hand removal efforts, a Late-Season EWM Peak Biomass Survey will qualitatively assess the hand harvesting efforts (Figure 3).

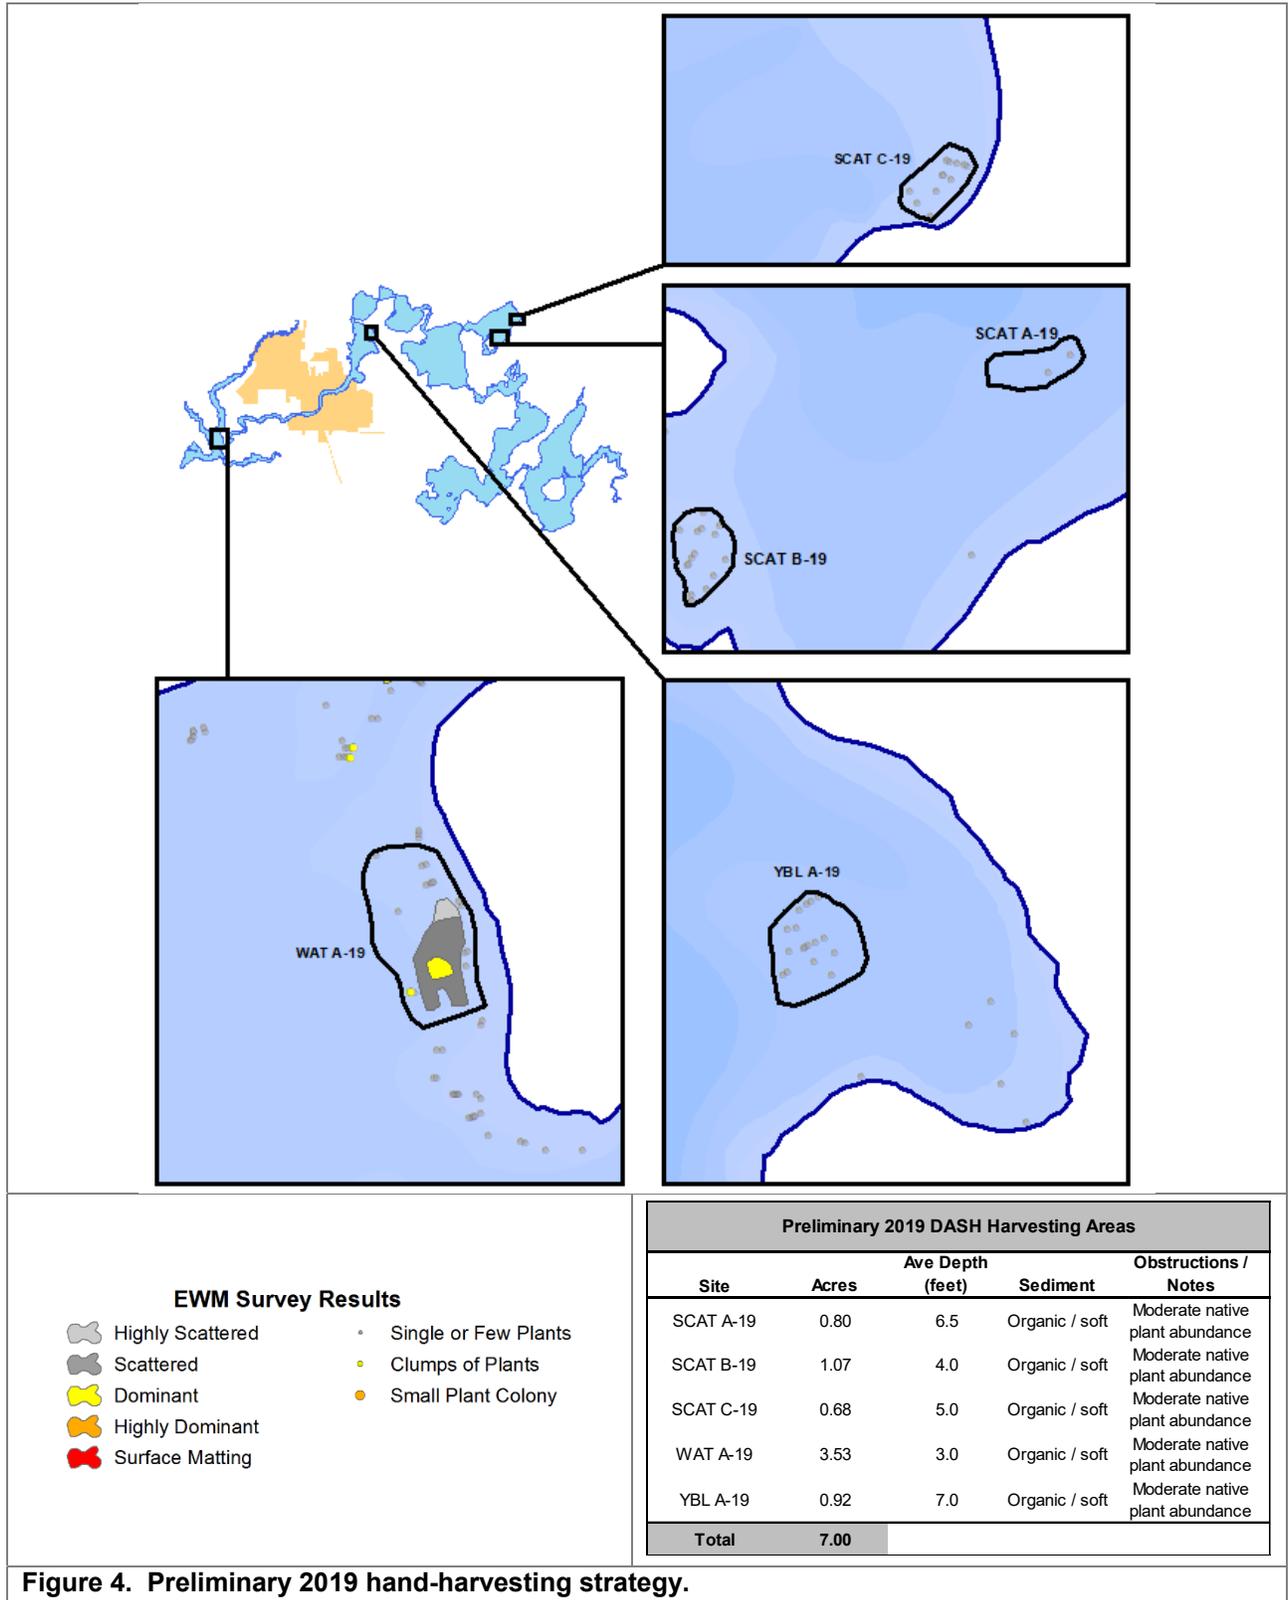
Figure 4. Preliminary 2019 hand-harvesting strategy.

A preliminary hand-harvesting EWM control strategy for 2019 includes considering all 2018 DASH hand-harvesting sites for implementation again in 2019 (Figure 4). Based upon the results of the Early-Season AIS Survey, areas will be potentially added, omitted, or revised. Onterra will provide the hand-harvesting firm with the spatial data from the early-July survey to aid the removal efforts.

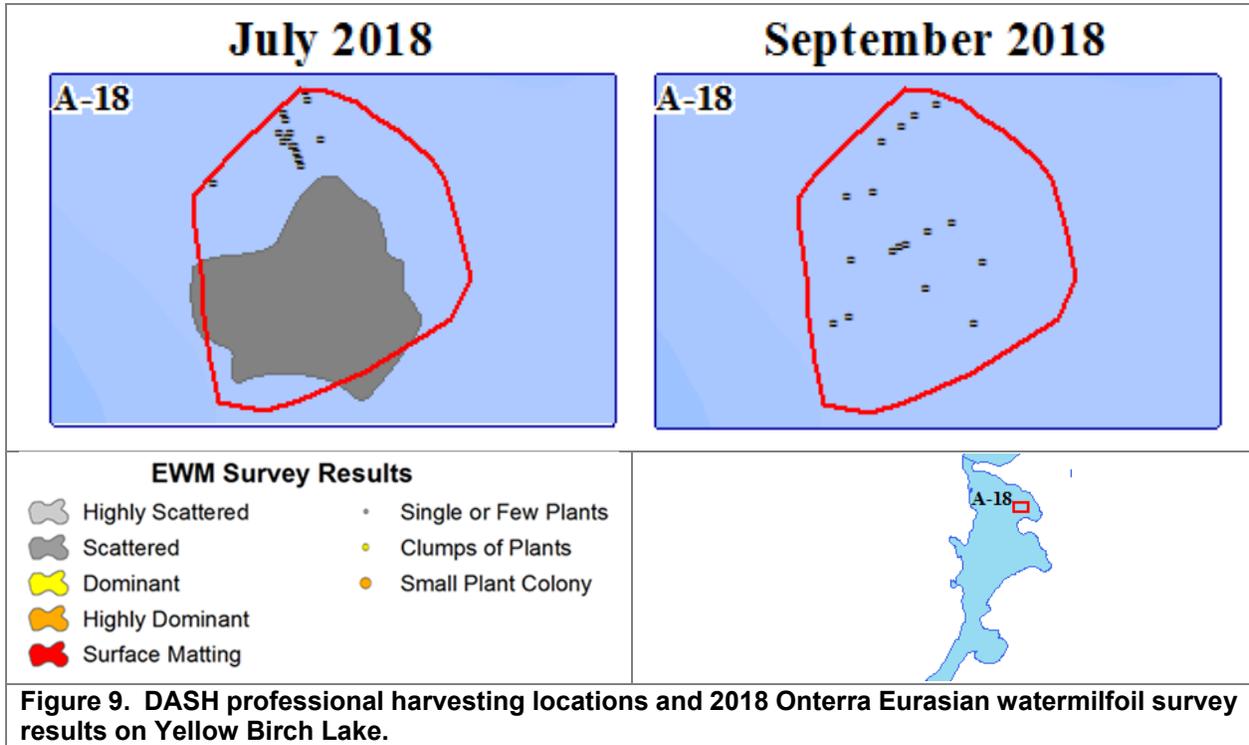
**YBL  
A-18**

The results of the Late-Season EWM Peak-Biomass Survey showed EWM in very similar areas to those found during the ESAIS Survey, but of reduced density (Yellow Birch Lake – Map 1). The hand-harvesting efforts were able to reduce *scattered* area of colonized EWM to only containing *single or few* EWM plant occurrences (Figure 9). The reduction of EWM within the hand-harvesting met the predetermined thresholds to be considered successful. This site will be again considered for hand-harvesting with DASH methodologies in 2019 pending the results of the 2019 ESAIS Survey Results.

Eurasian watermilfoil mapped in some parts of Yellow Birch Lake, particularly within the downstream Eagle River, is beginning to show signs of re-establishment and recovery. The colonized EWM acreage in Yellow Birch Lake has stayed below 1 acre for the past four Late-Summer EWM Mapping Surveys, from 2015-2018.

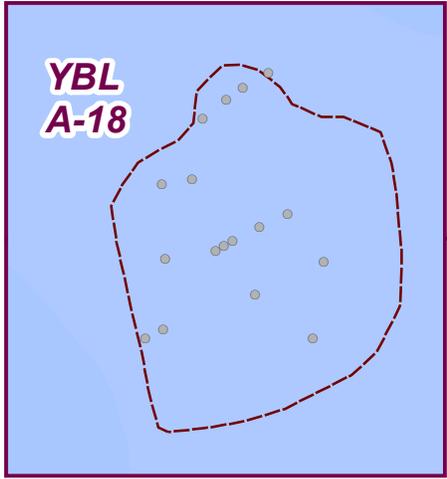
Diver Assisted Suction Harvesting (DASH) of Eurasian Water Milfoil (EWM) took place on August 7 & 20, 2018 on Yellow Birch Lake, Vilas Co., Wisconsin. A survey performed by Onterra, LLC confirmed the locations of EWM on 0.92 acres in one area that was targeted for harvest. The attached map was provided by Onterra, LLC. All areas were exclusively targeted for EWM.

Area YBL A-18, was harvested for EWM using the DASH barge with one diver on hookah air supply and another person on the barge collecting the material in mesh bags. The wind was at calm, waves were calm, air temp was 72 degrees working at a depth of 7 feet.

Area YBL A-18: 7 hours with a total of 76 lbs. of material harvested (approx. 10% non-target plants)

Area YBL A-18, was harvested for EWM using the DASH barge with one diver on hookah air supply and another person on the barge collecting the material in mesh bags. The wind was at calm, waves were calm, air temp was 70 degrees working at a depth of 7 feet.

Area YBL A-18: 3 hours with a total of 20 lbs. of material harvested (approx. 10% non-target plants)
