Onterra LLC
 Lake Management Planning
 815 Prosper Road
 De Pere, WI 54115
 920.338.8860
 www.onterra-eco.com

Catfish Lake
 Vilas County, Wisconsin
2018 ESAIS
Survey Results: EWM

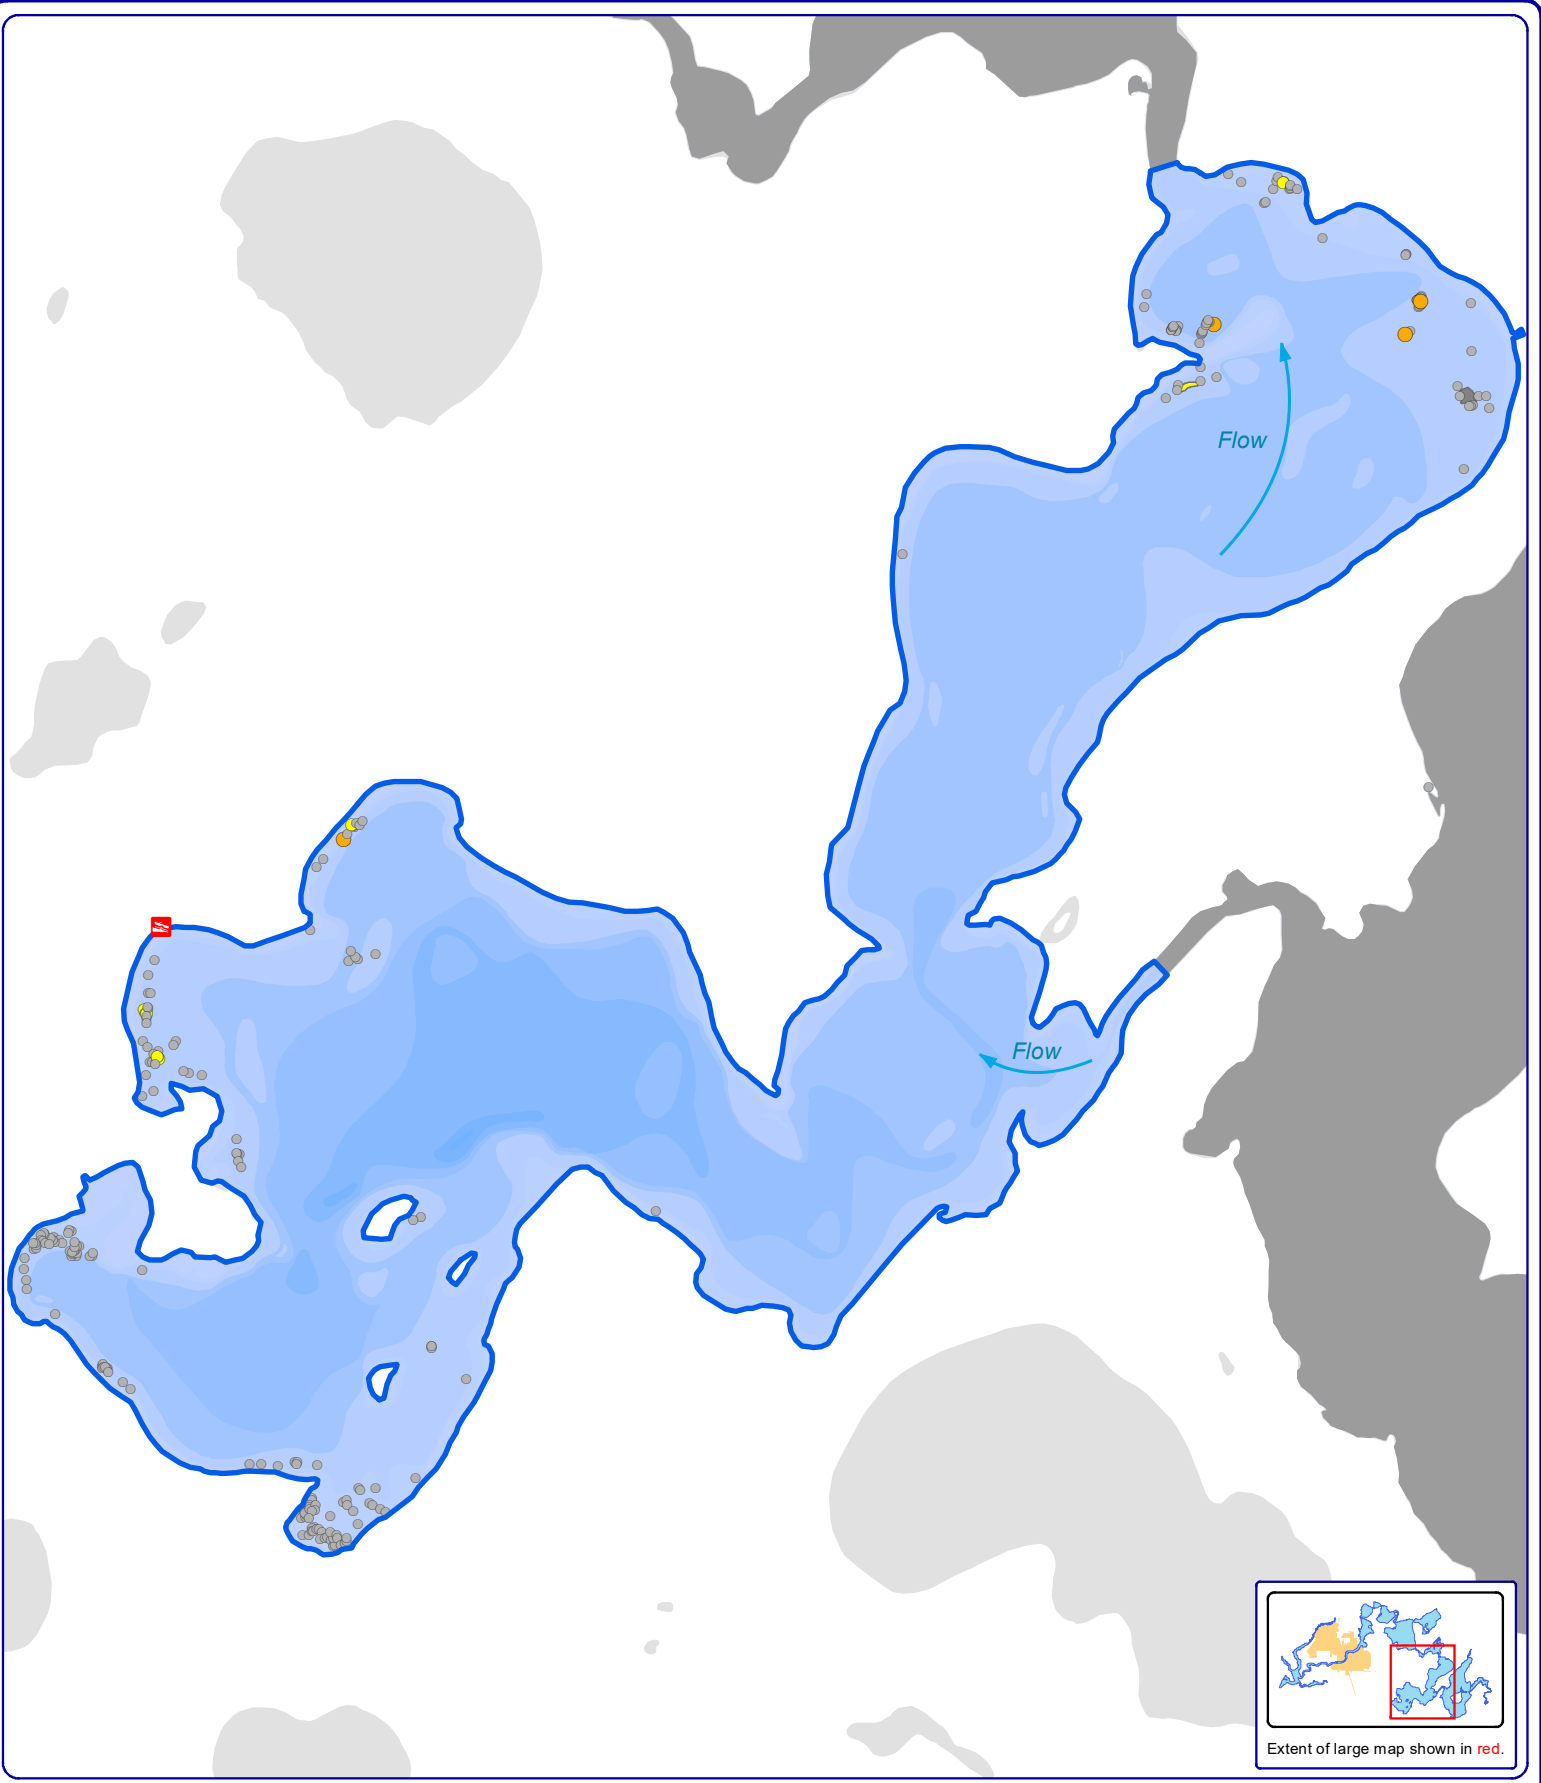
Legend
2018 ESAIS Survey (Early-July 2018)

- Highly Scattered (*None found*)
- Scattered
- Dominant
- Highly Dominant (*None found*)
- Surface Matting (*None found*)
- Single or Few Plants
- Clumps of Plants
- Small Plant Colony
