2017 Final DASH Harvesting Areas

Scattering Rice Lake
 Vilas County, Wisconsin

2017 ESAIS
Survey Results: EWM

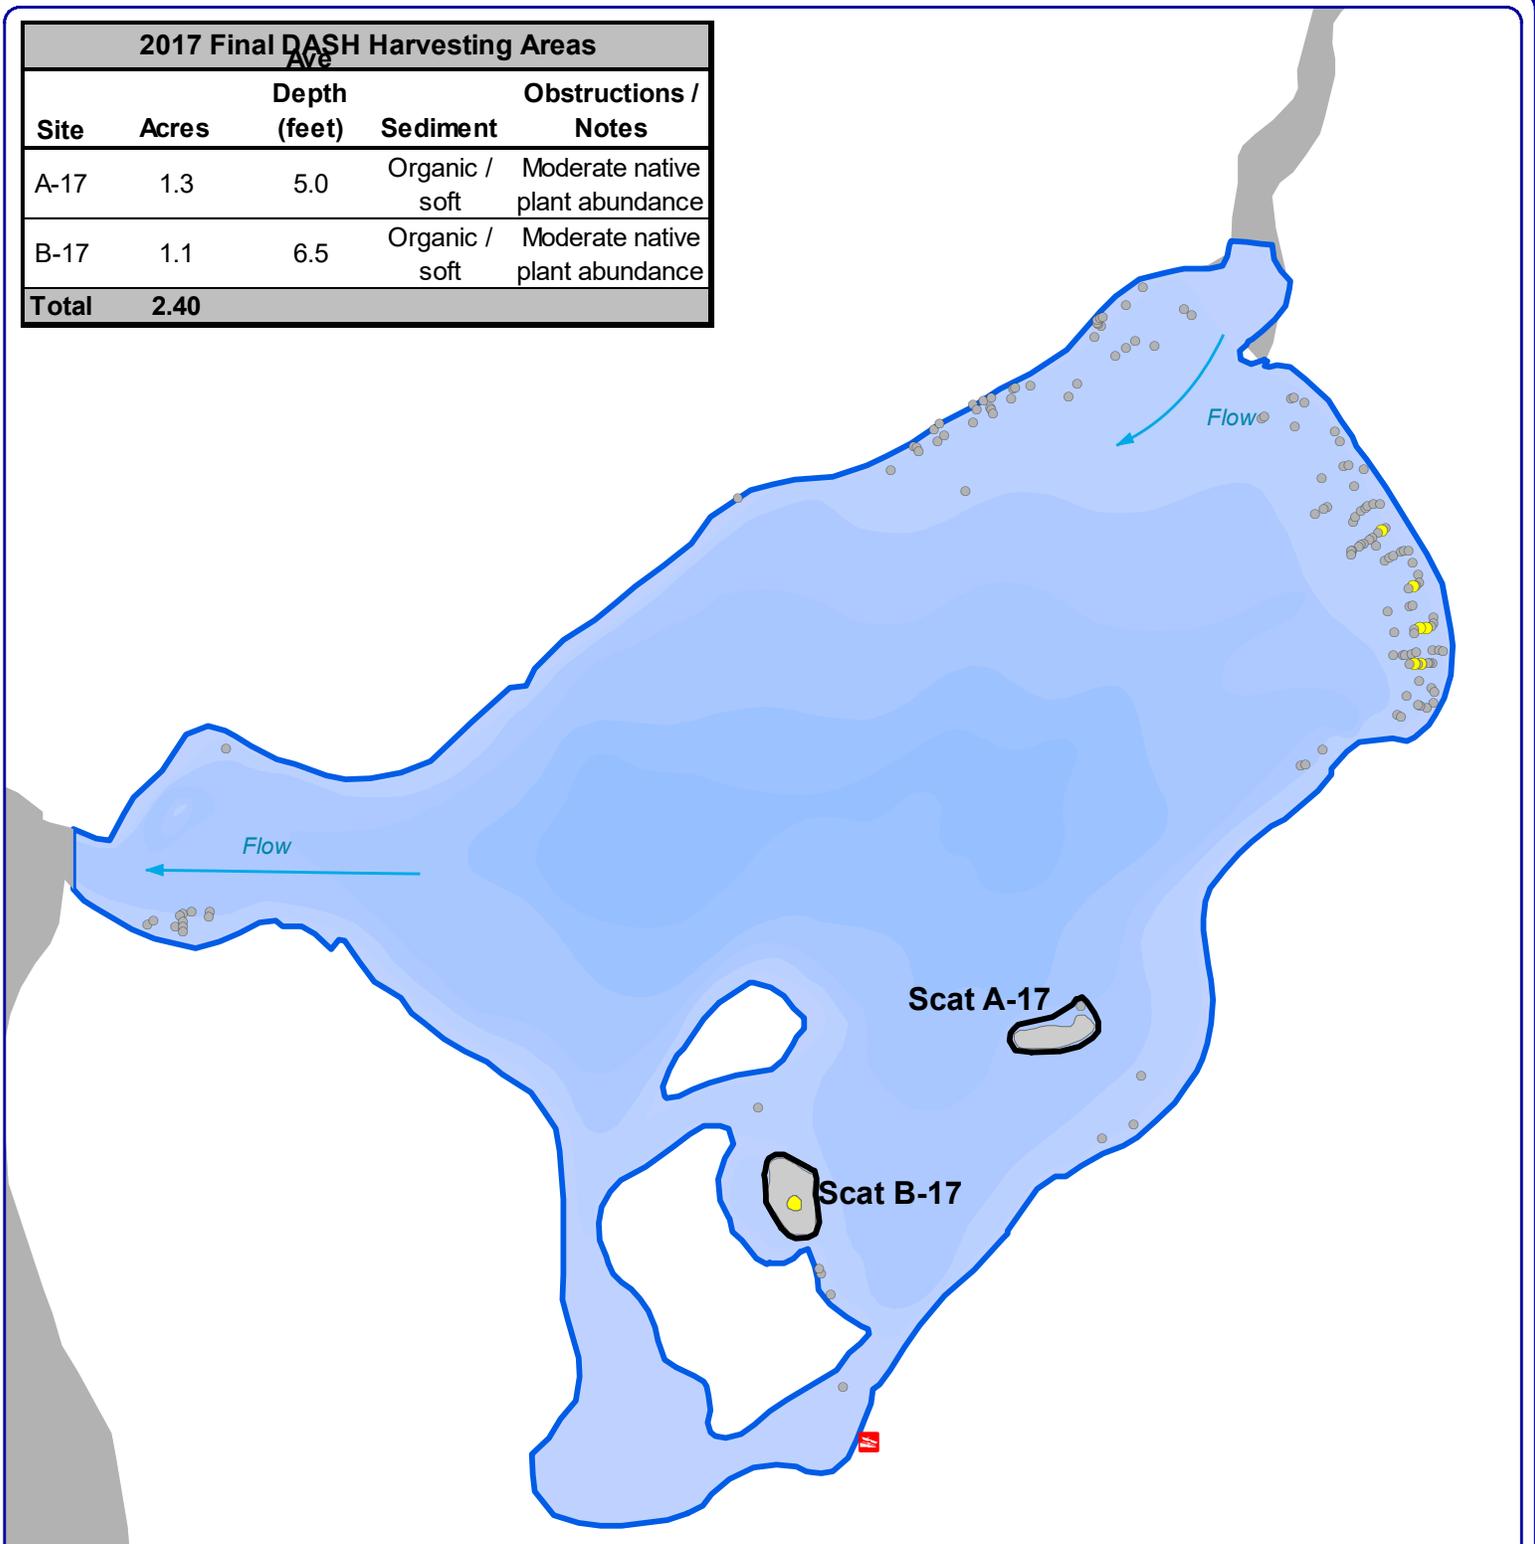
Site	Acres	Depth (feet)	Sediment	Obstructions / Notes
A-17	1.3	5.0	Organic / soft	Moderate native plant abundance
B-17	1.1	6.5	Organic / soft	Moderate native plant abundance
Total	2.40

- Highly Scattered
- Scattered (None found)
- Dominant
- Highly Dominant (None found)
- Surface Matting (None found)
- Single or Few Plants
- Clumps of Plants
- Small Plant Colony (None found)
