Onterra LLC
Lake Management Planning
815 Prosper Road
De Pere, WI 54115
920.338.8860
www.onterra-eco.com

Catfish Lake
Vilas County, Wisconsin
**July 2020 EWM
Survey Results &
Final DASH Sites**

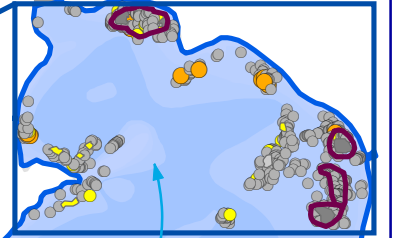
Final 2020 DASH Harvesting Areas Catfish Lake				
Site	Acres	Ave Depth (feet)	Sediment	Obstructions / Notes
Cat A-20	2.19	4.5	Sand	floating-leaf plant community
Cat B-20	1.00	5.0	Organic / soft	Moderate native plant abundance
Cat C-20	1.01	5.5	Organic / soft	Moderate native plant abundance
Cat D-20	1.01	5.0	Organic / soft	Moderate native plant abundance
Total	5.21
