Eagle River Chain of Lakes

2023 EWM Management and Monitoring Report

April 2024

Created by: Todd Hanke, Eddie Heath, and Tim Hoyman
Onterra, LLC
De Pere, WI

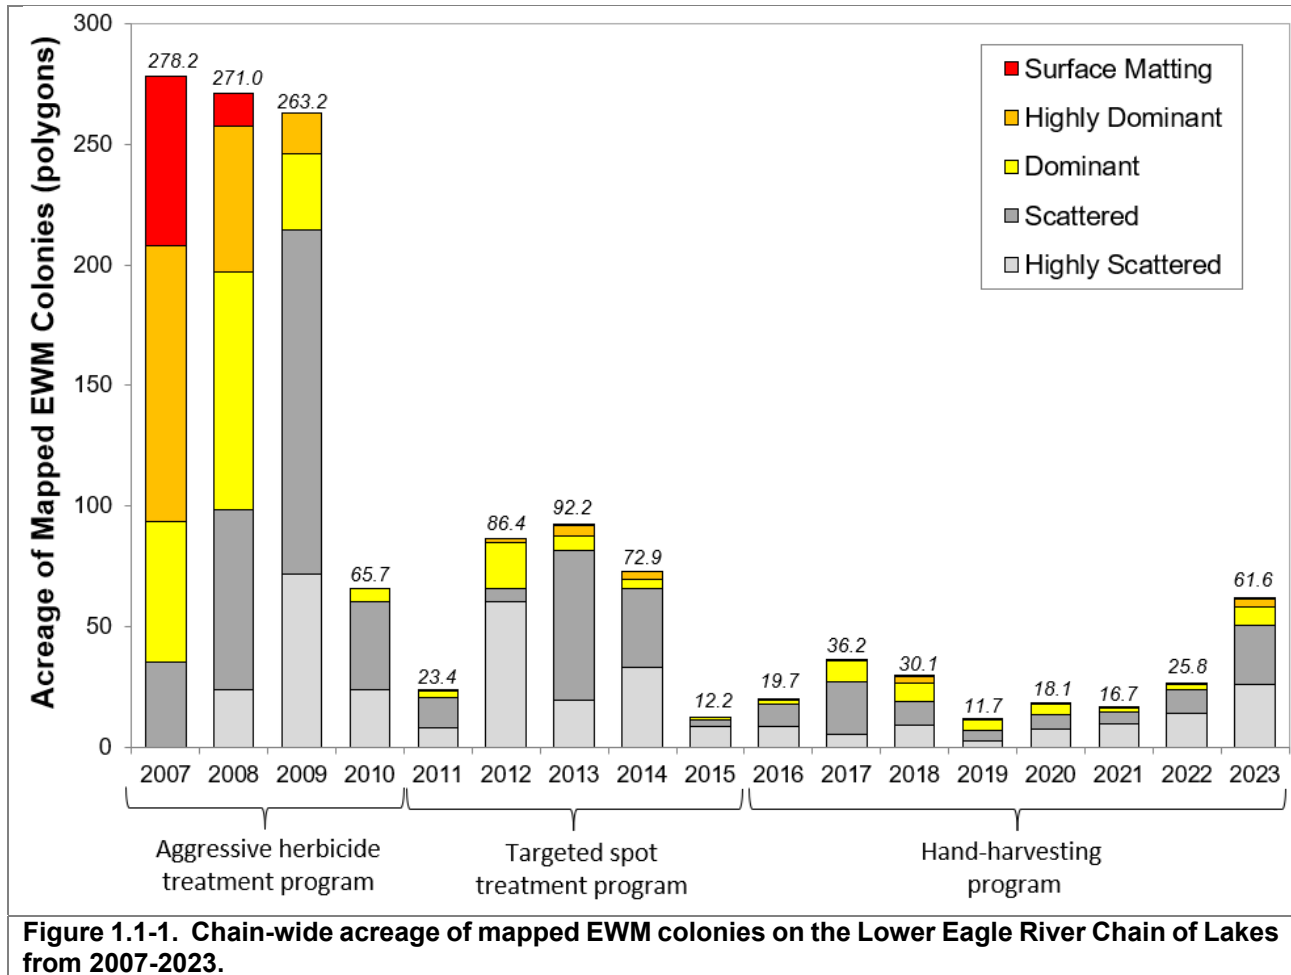
Starting in 2007, late-season EWM mapping surveys commenced on the Eagle River Chain of Lakes using a consistent density rating system (Figure 1.1-1). Please note that this figure only represents the acreage of mapped EWM polygons, not EWM mapped with point-based methodologies (*single or few plants, clumps of plants, or small plant colonies*). In other words, EWM marked with point-based mapping methods do not contribute to the colonized acreage shown in Figure 1.1-1.

Ongoing studies stemming from this project indicate that in small spot treatments, the herbicide dissipates too rapidly to cause EWM mortality if traditional weak-acid auxin systemic herbicides like 2,4-D are used. Even in some cases where larger treatment areas can be constructed, their narrow shape or exposed location within a lake may result in insufficient herbicide concentrations and exposure times for long-term control. With this knowledge, more effective herbicide spot treatment strategies were implemented in the latter years of this phase of management. In 2015, the EWM population of the Eagle River Chain of Lakes was at its lowest levels in over a decade, with just over 12 acres of colonized EWM being documented chain-wide (Figure 1.1-1).

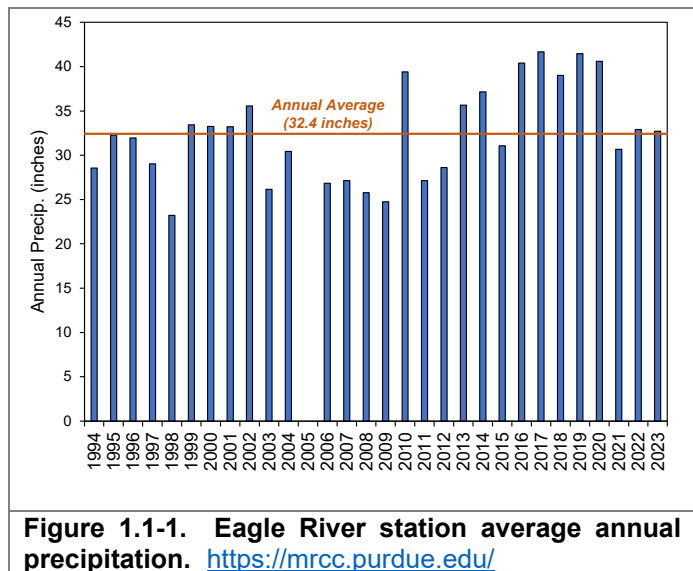
Figure 1.1-1. Eagle River station average annual precipitation. <https://mrcc.purdue.edu/>

Correlation analysis between precipitation data and average summer Secchi disk depth revealed that total growing season precipitation (April-September) had the strongest negative correlation with average summer Secchi disk depth (Figure 1.1-1. This means that as precipitation increases, water clarity decreases. The increase in precipitation may have resulted in increased phosphorus loading to the chain, increasing algal production and reducing water clarity. The increased precipitation may have also increased the amount of dissolved humic substances within the chain, increasing the stained appearance and decreasing water clarity.

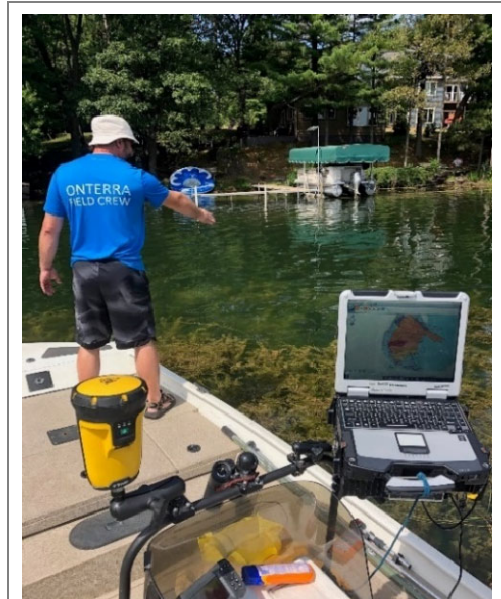
Photo 1.1-2. EWM mapping survey on a WI lake. Photo credit Onterra.

A series of EWM mapping surveys were used to coordinate and monitor the hand-harvesting efforts. During the EWM mapping survey, the entire littoral area of the lake is surveyed through visual observations from the boat (Photo 1.1-2). A preliminary hand harvesting strategy is developed over the fall/winter based on the results of the previous year's Late-Summer EWM Mapping Survey. In late-spring/early summer, an Early Season Aquatic Invasive Species Survey (ESAIS) is completed from which the hand-harvesting strategy was finalized. After the professional hand-harvesting activities are completed, Onterra completes the Late-Summer EWM Mapping Survey, the results of which serve as a post-harvesting assessment of the hand-removal efforts. The hand-removal program would be considered successful if the EWM population within the targeted areas was found to have been reduced and inhibited from expanding between the year before and year after Late-Summer EWM Mapping Surveys.

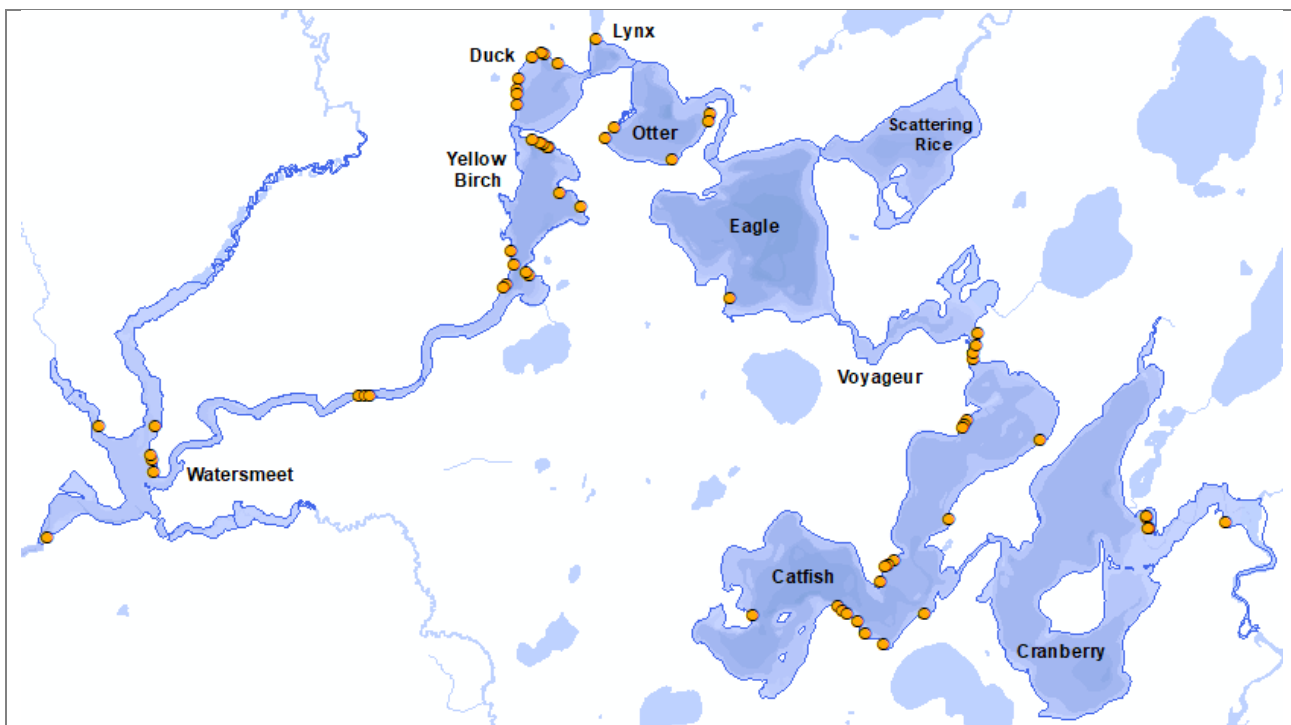
Figure 2.2-1 Suspected EWM locations marked by ELERCLC volunteers in 2023. Volunteer points displayed as orange circles.

In recent years, a team of dedicated ULERCLC volunteers have conducted EWM monitoring efforts during the summer months. These efforts have been instrumental in aiding professional monitoring efforts through searching the Chain for new EWM infestations. Volunteers use a dedicated GPS unit that is loaded with the most recent professional EWM mapping survey results. The volunteer team focuses on searching for EWM in other areas of the Chain outside of where known EWM populations have been recently documented in the professional mapping surveys. If volunteers encounter a new suspected occurrence of EWM, a waypoint is taken on the GPS unit. All volunteer data is ultimately provided to Onterra prior to the next scheduled professional mapping survey. This allows the professional surveyors to visit the volunteer locations to confirm the presence of EWM. In 2023, ULERCLC volunteer monitoring efforts identified suspected EWM within all waterbodies with the exception of Scattering Rice Lake (Figure 2.2-1).
