Eagle River Chain of Lakes

2023 EWM Management and Monitoring Report

April 2024

Created by: Todd Hanke, Eddie Heath, and Tim Hoyman
Onterra, LLC
De Pere, WI

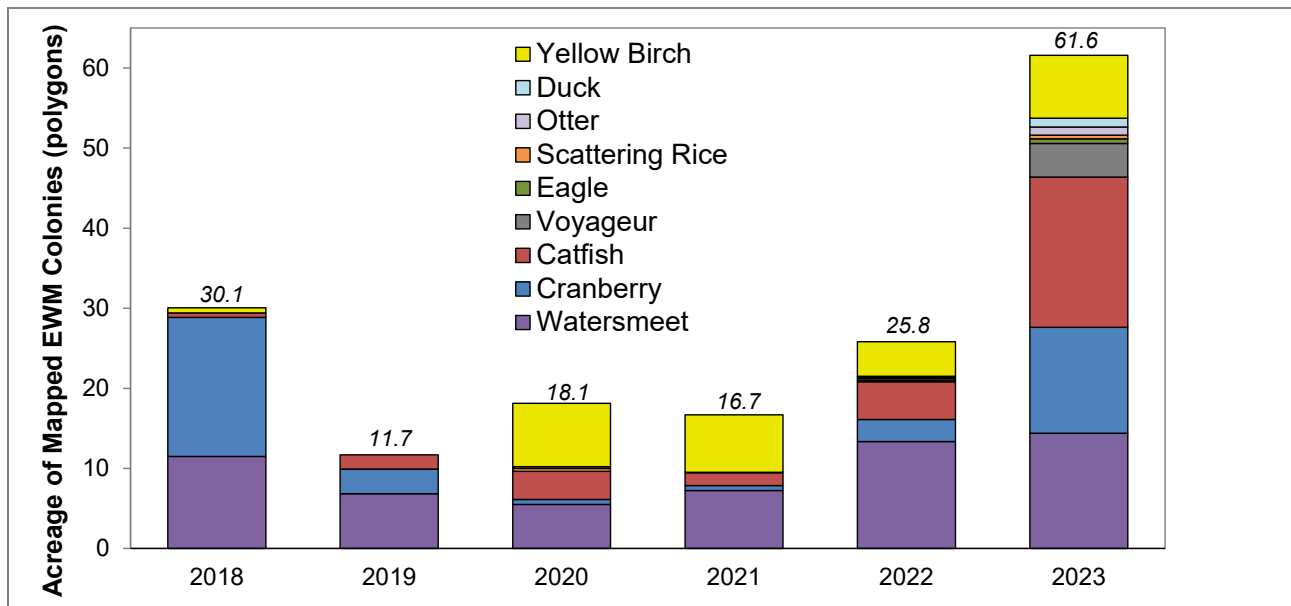
As shown on Figure 2.3-1, 61.6 acres of EWM was located during the 2023 Late-Season EWM Mapping Survey on the Chain. This is an increase compared to the 25.8 acres mapped in 2022 and is aligned with acreages of colonized EWM documented annually from 2011-2015. The majority of the EWM acreage mapped in the Eagle River Chain of Lakes was in Catfish, Cranberry, and Watersmeet Lakes. The EWM within Watersmeet is largely located in channelized areas where water flow is higher. Past herbicide treatments conducted in this area revealed it is difficult to achieve the needed concentration and exposure time to achieve EWM mortality. All lakes within the chain, with the exception of Lynx Lake, experienced an increase in EWM during 2023 when compared to 2022.

Figure 2.3-1. Distribution of acreage of mapped EWM colonies by lake in 2018-2023.
