Eagle River Chain of Lakes

2023 EWM Management and Monitoring Report

April 2024

Created by: Todd Hanke, Eddie Heath, and Tim Hoyman
Onterra, LLC
De Pere, WI

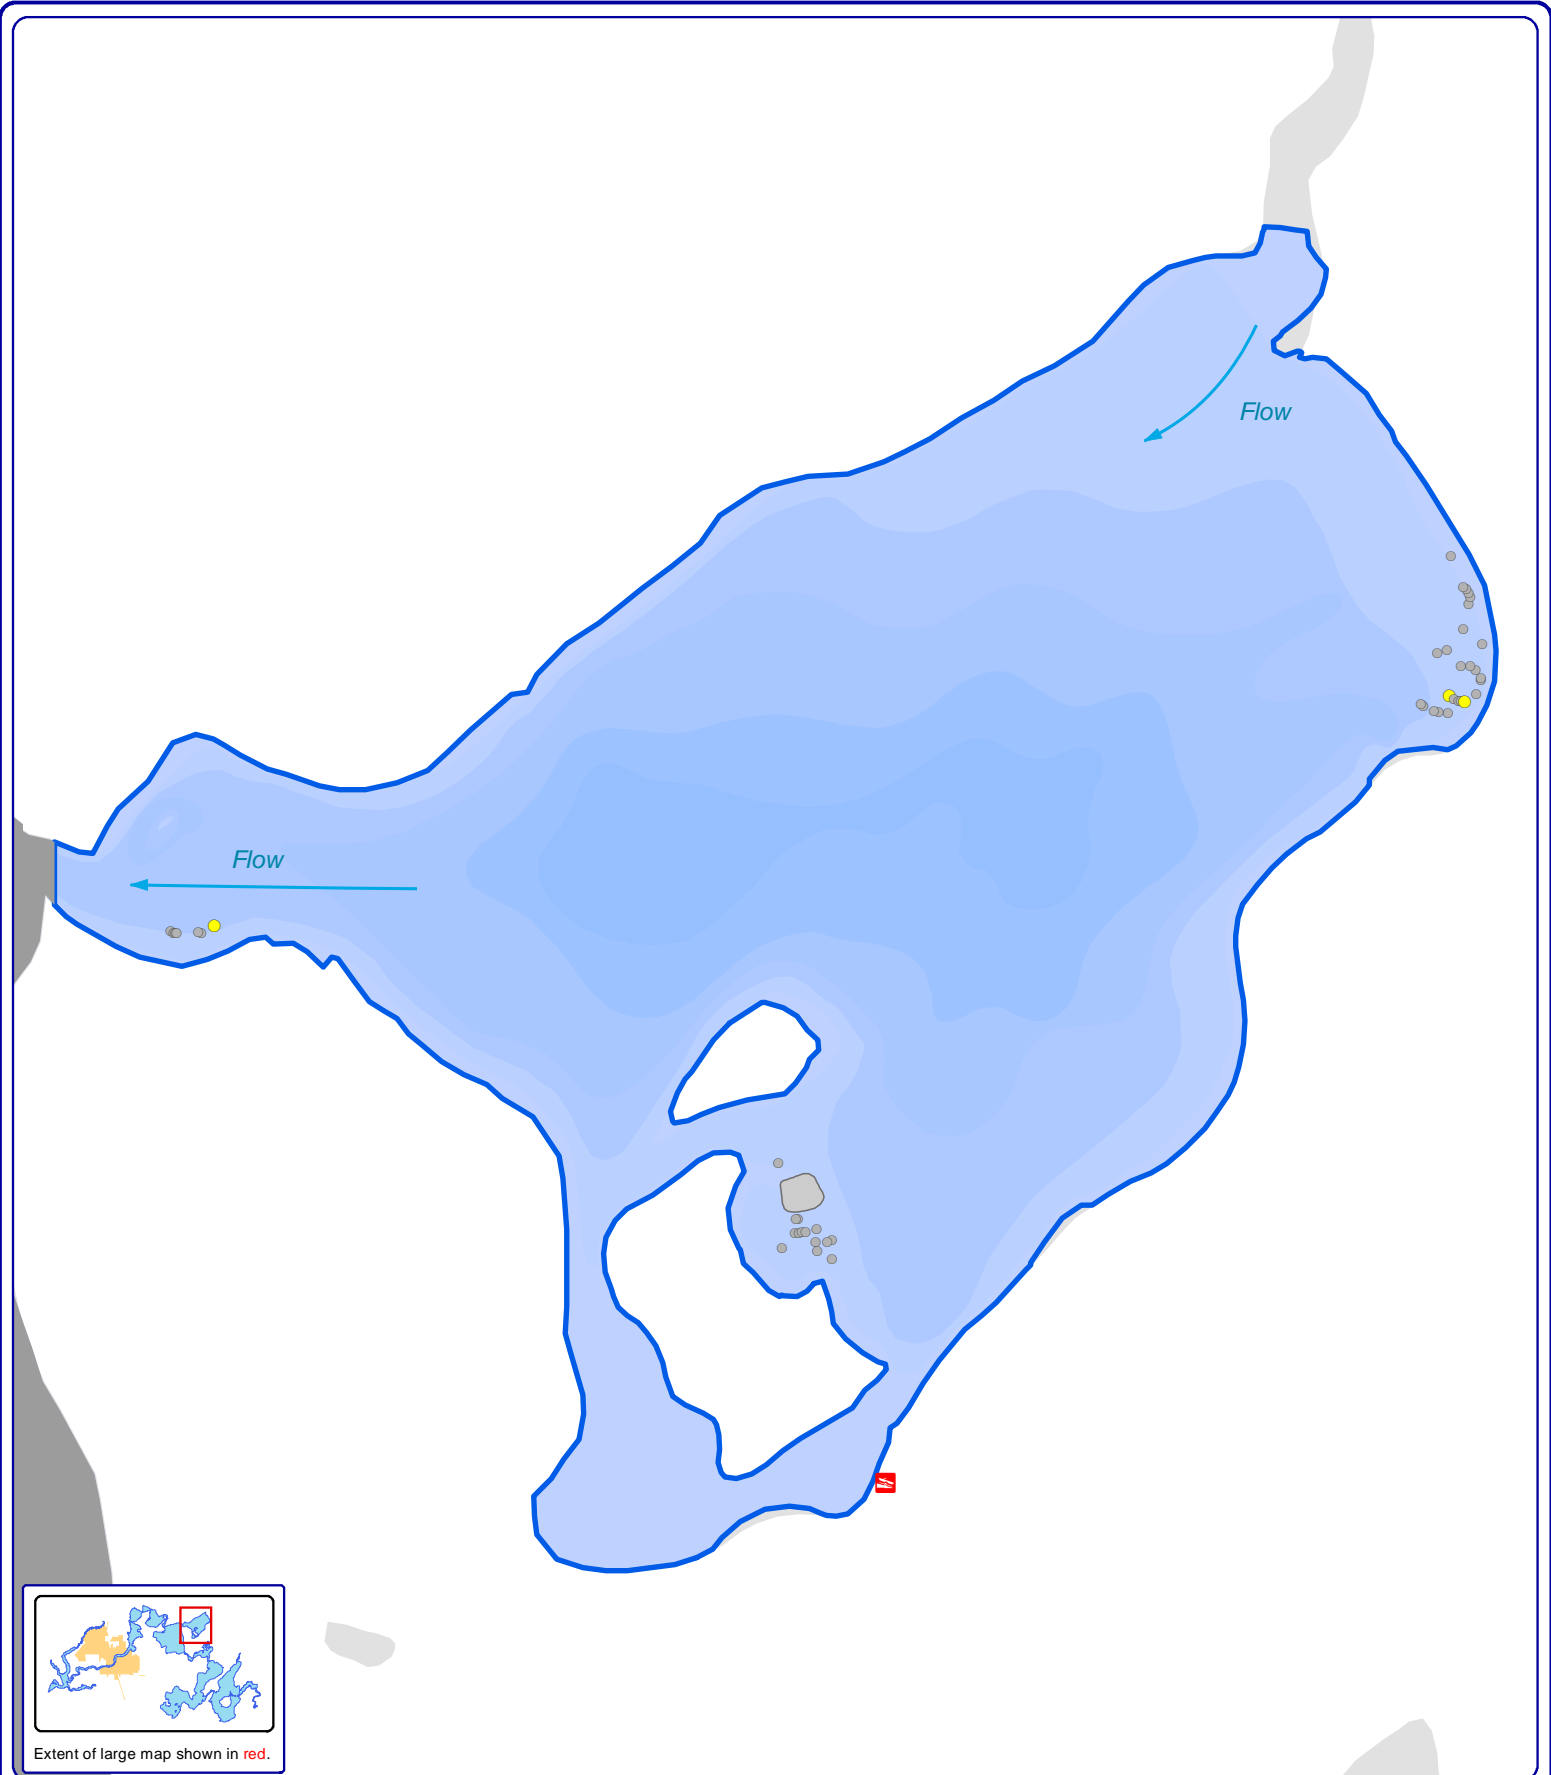
Map 5
 Scattering Rice Lake
 Vilas County, Wisconsin
**2023 Late-Season
 EWM Survey Results**

A modest EWM population has been documented in Scattering Rice Lake in recent surveys and no areas were actively managed during 2023. The 2023 Late-Season EWM Mapping Survey documented a modest population within Scattering Rice Lake with several isolated *single or few plants* occurrences located as well as a small *highly scattered* colony within the lake (Map 5). No EWM management activities are currently planned for 2024 in Scattering Rice Lake. Professional EWM monitoring will continue during 2024 including early and late-season AIS surveys.
